HV Items from Long Bo

MicroBooNE R&D Meeting
April 25, 2014

Slides by S. Lockwitz

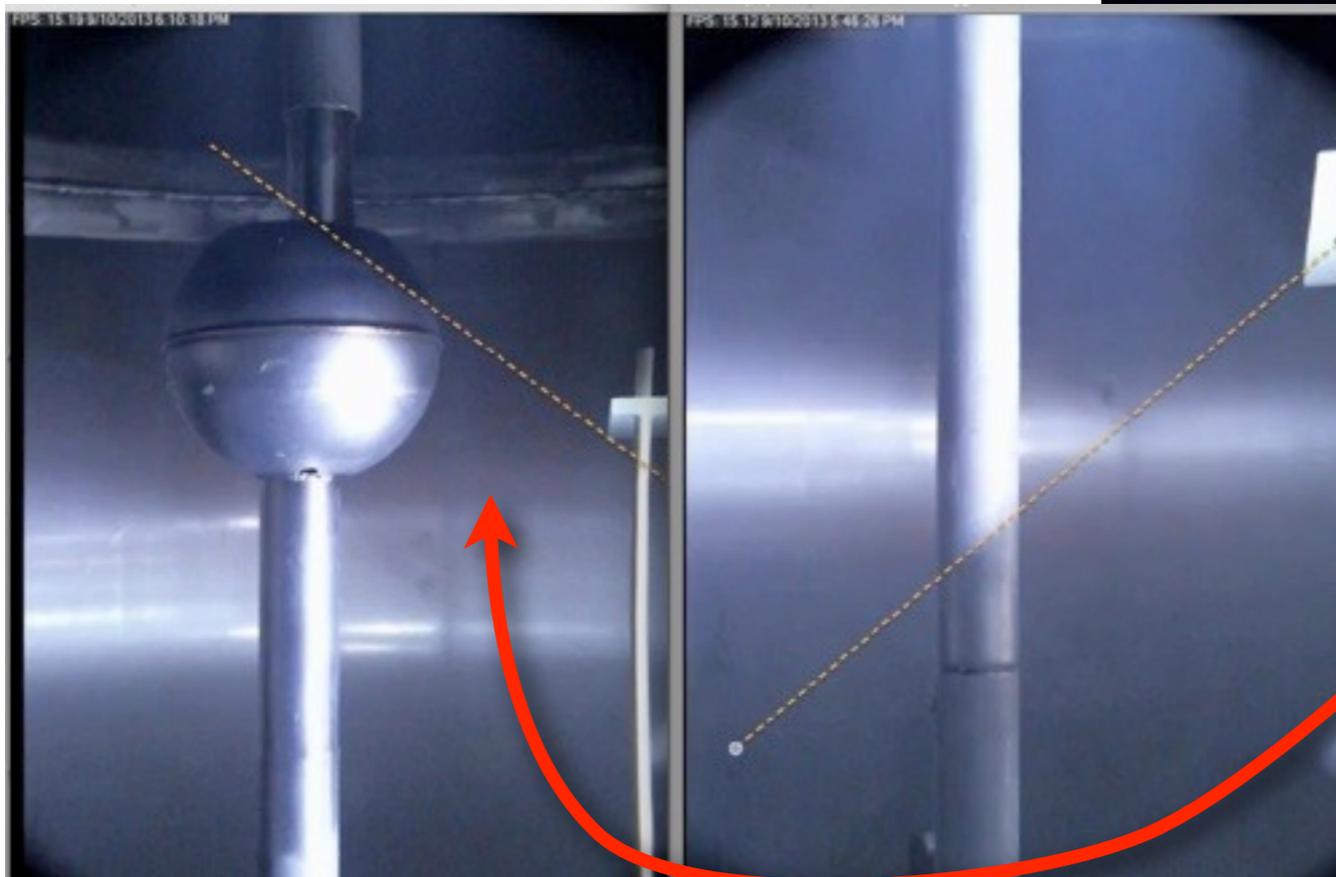
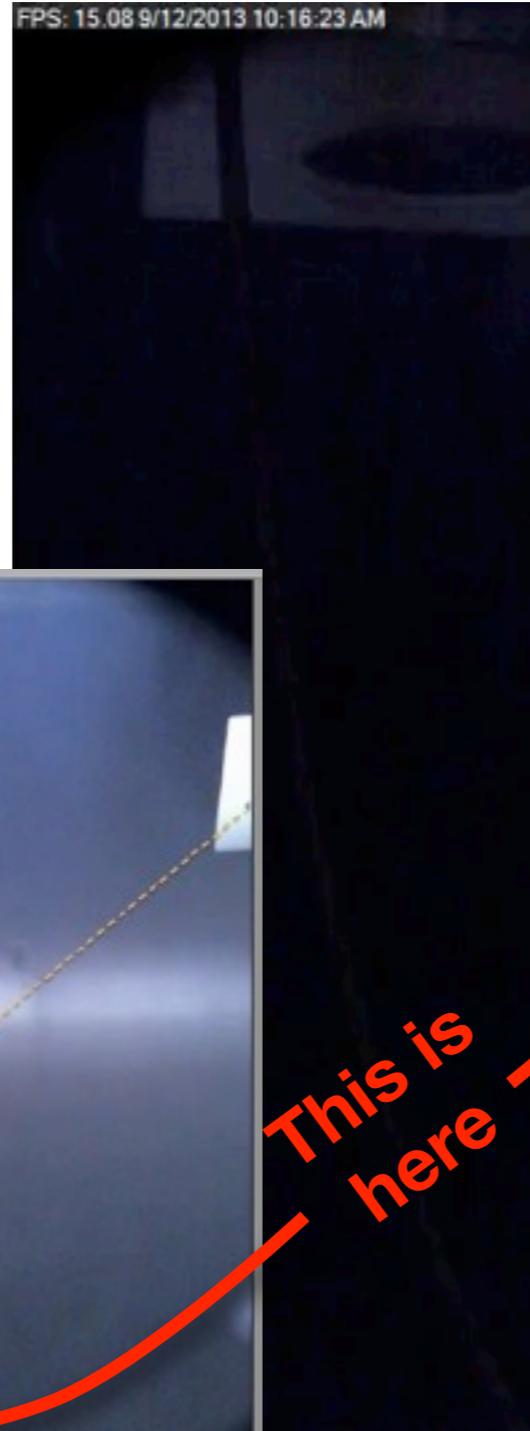
This is here

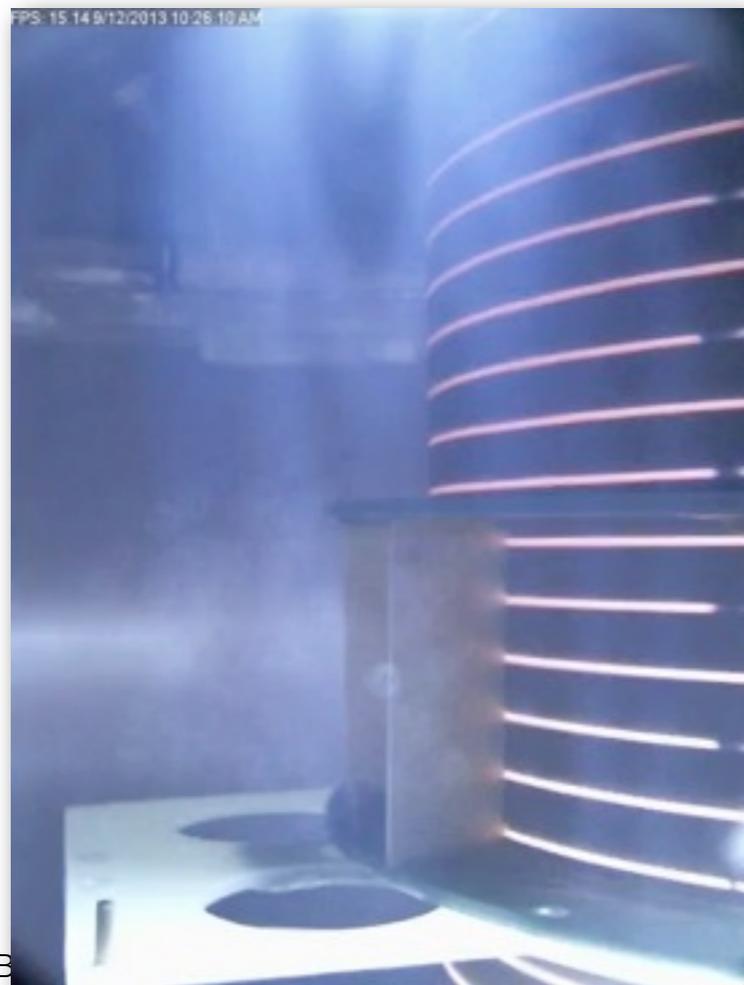
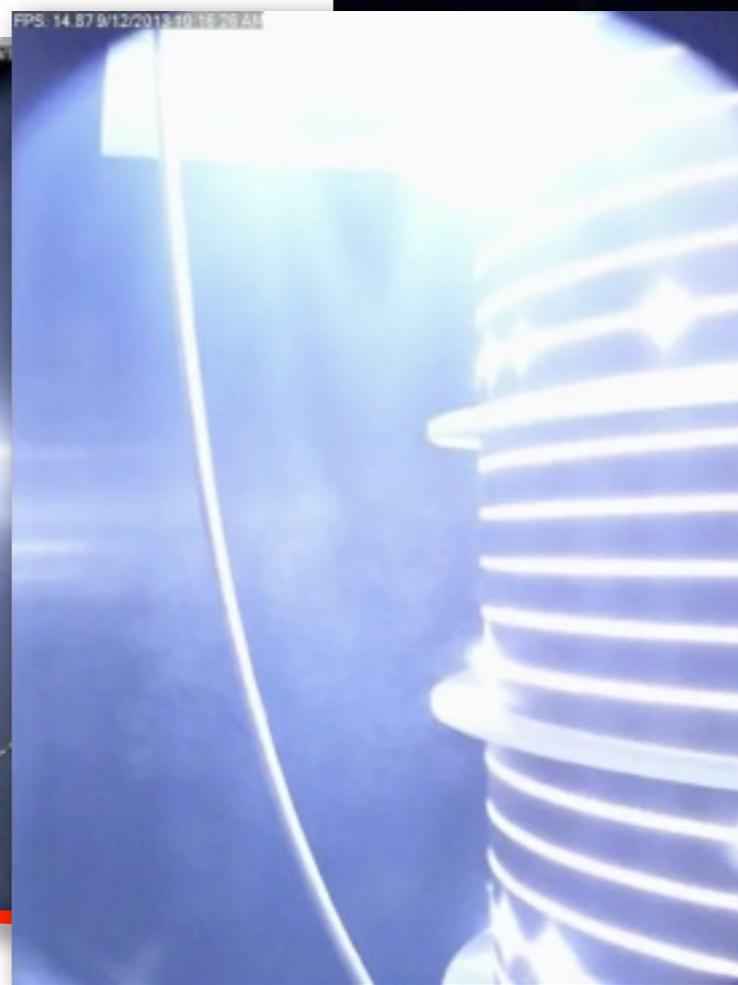
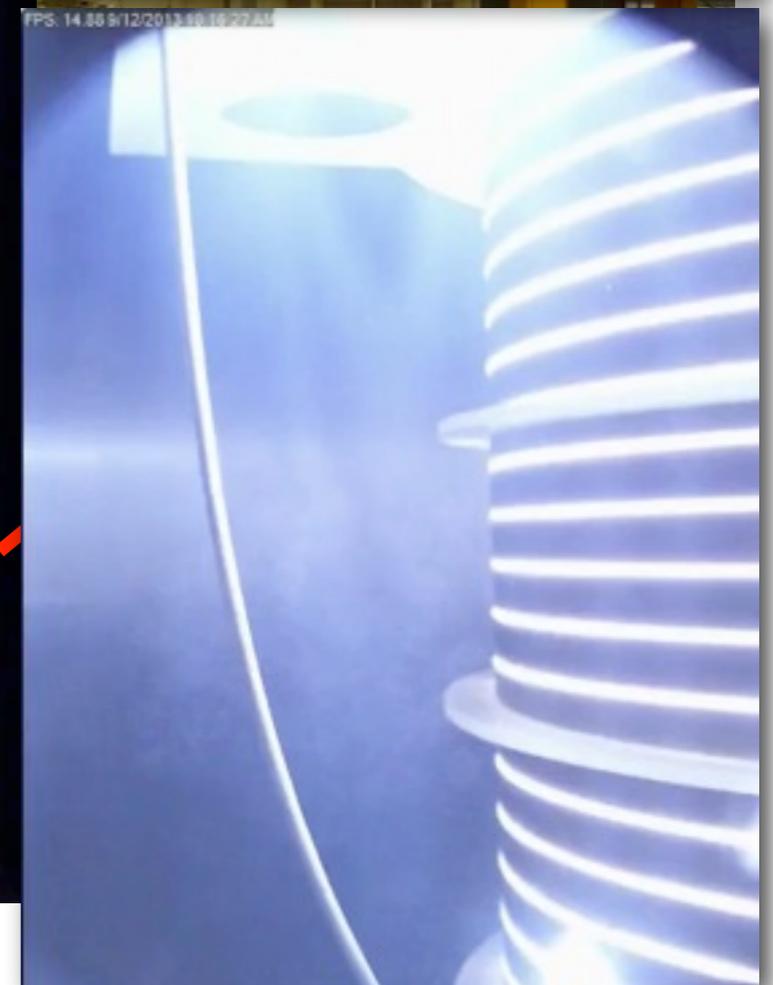
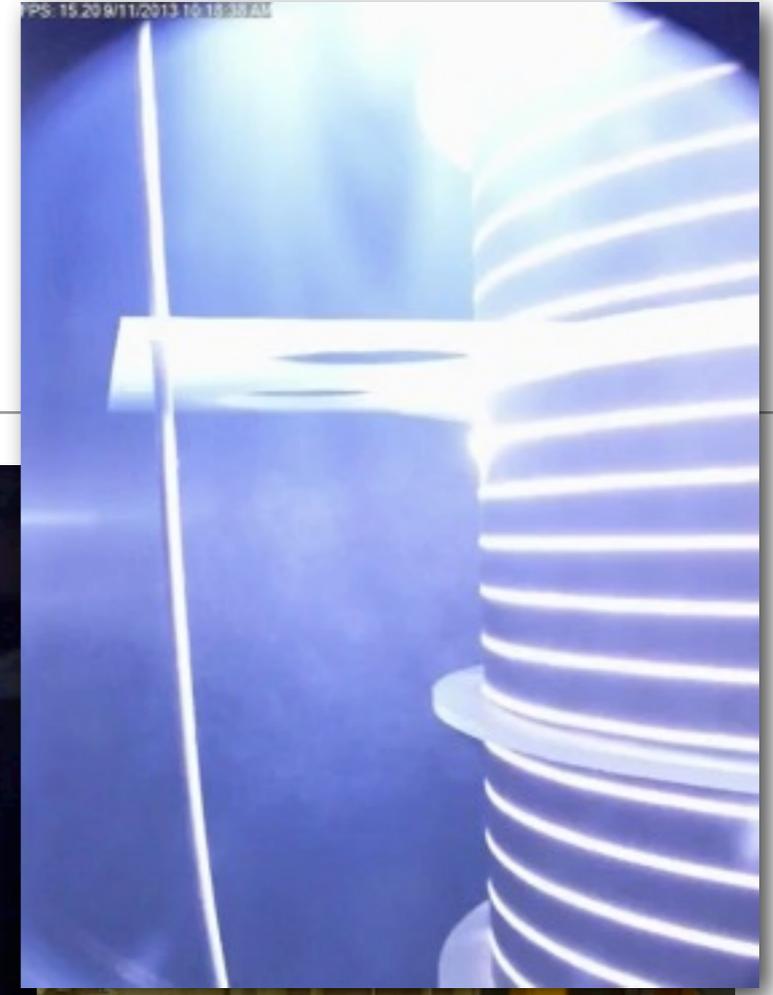
- We eventually put a camera in LAPD (provided by BERN)
- Amazing photos...

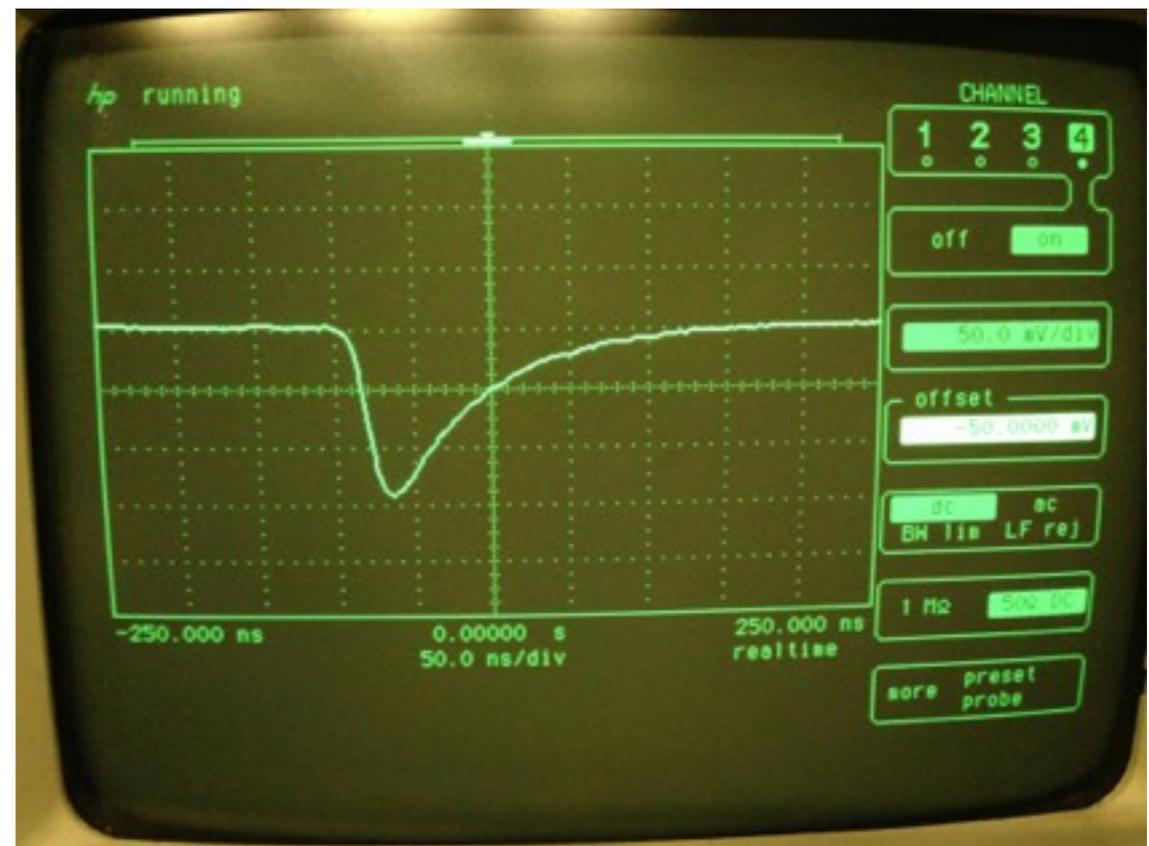
- H. Jostlein had an idea:
 - Very frequent breakdowns across resistors act like a current
 - If this is true, there should be little sparks
- He put a PMT on a flange window (blocked out the other)
- Yes! There were sparks:

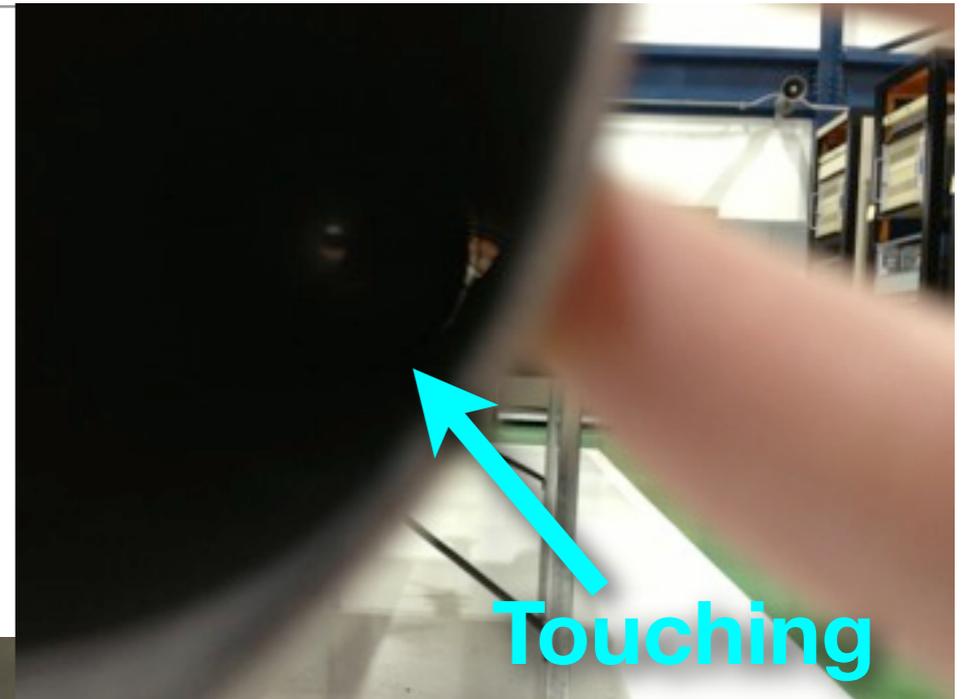
- Unfortunately, when we pulled the FT, the setup was damaged
 - The peak screws were sheared and the distance during testing cannot be known
 - Bummer

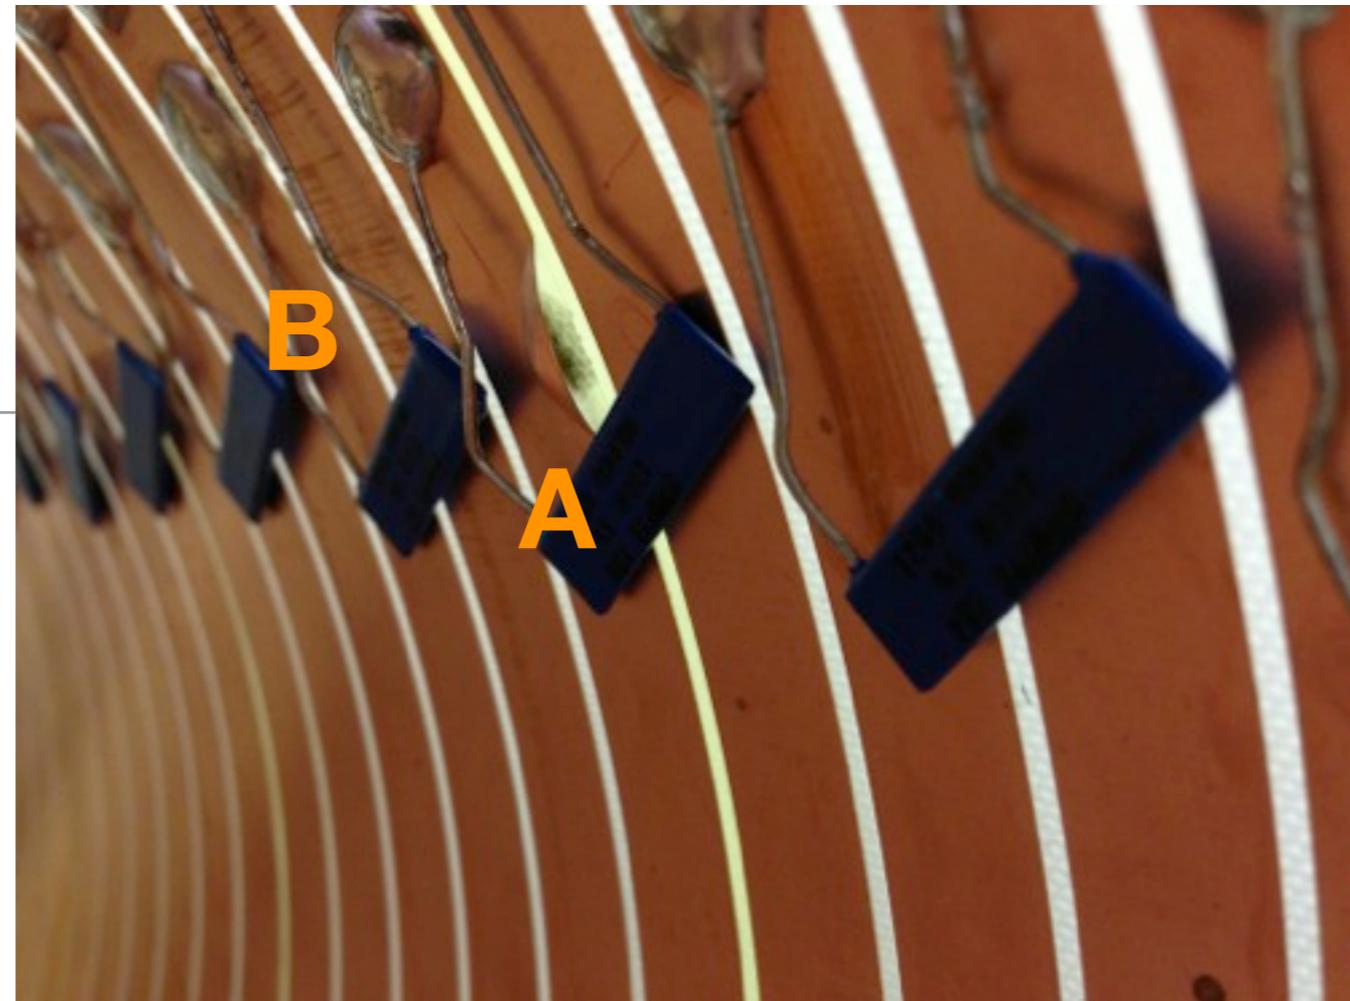
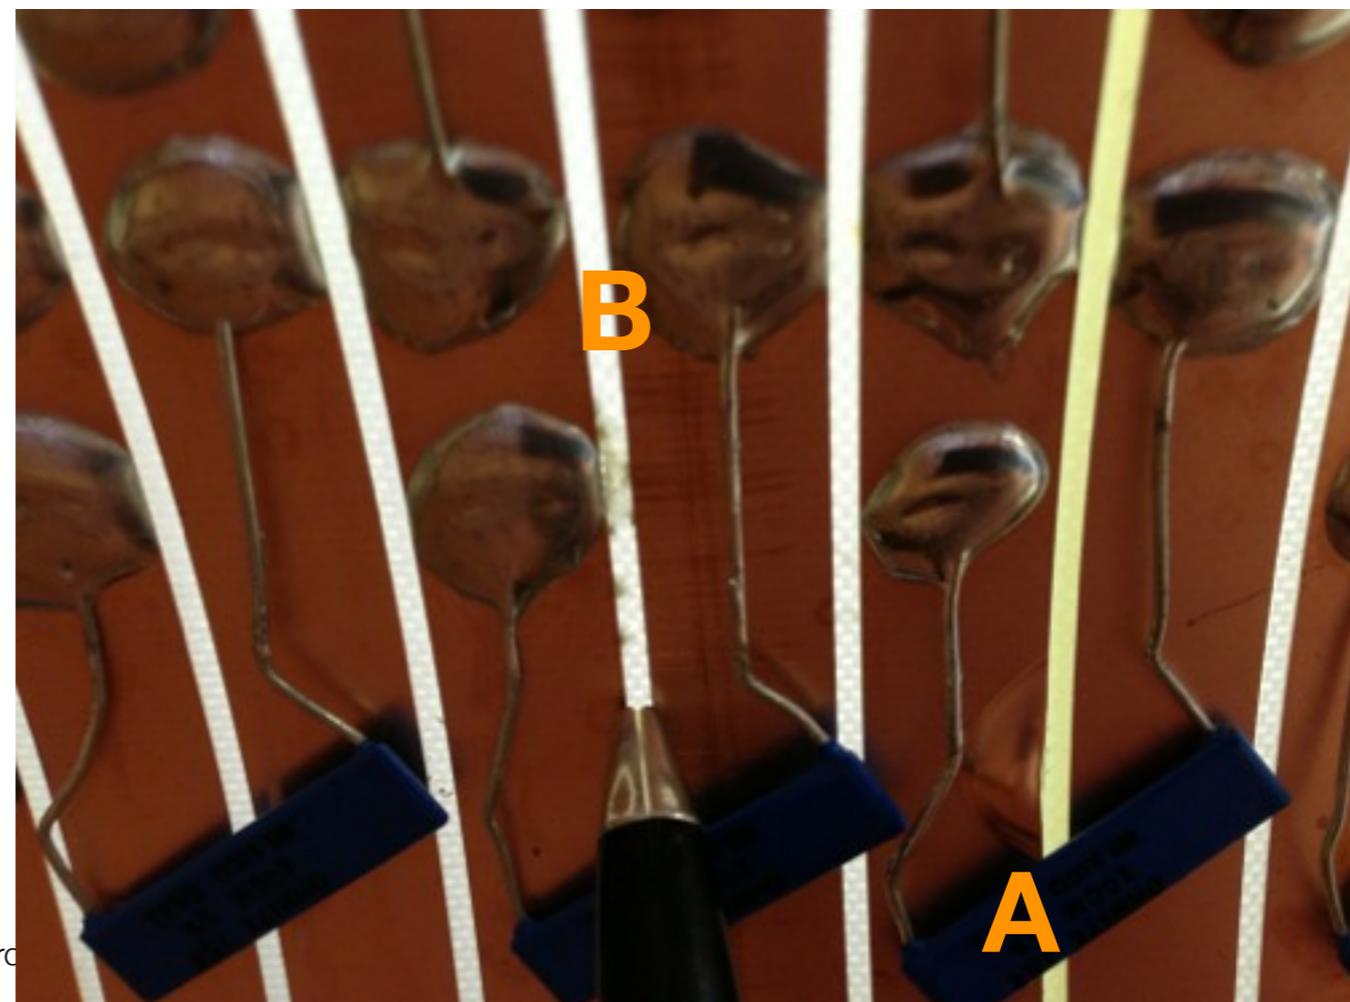
Note: Carbon traces

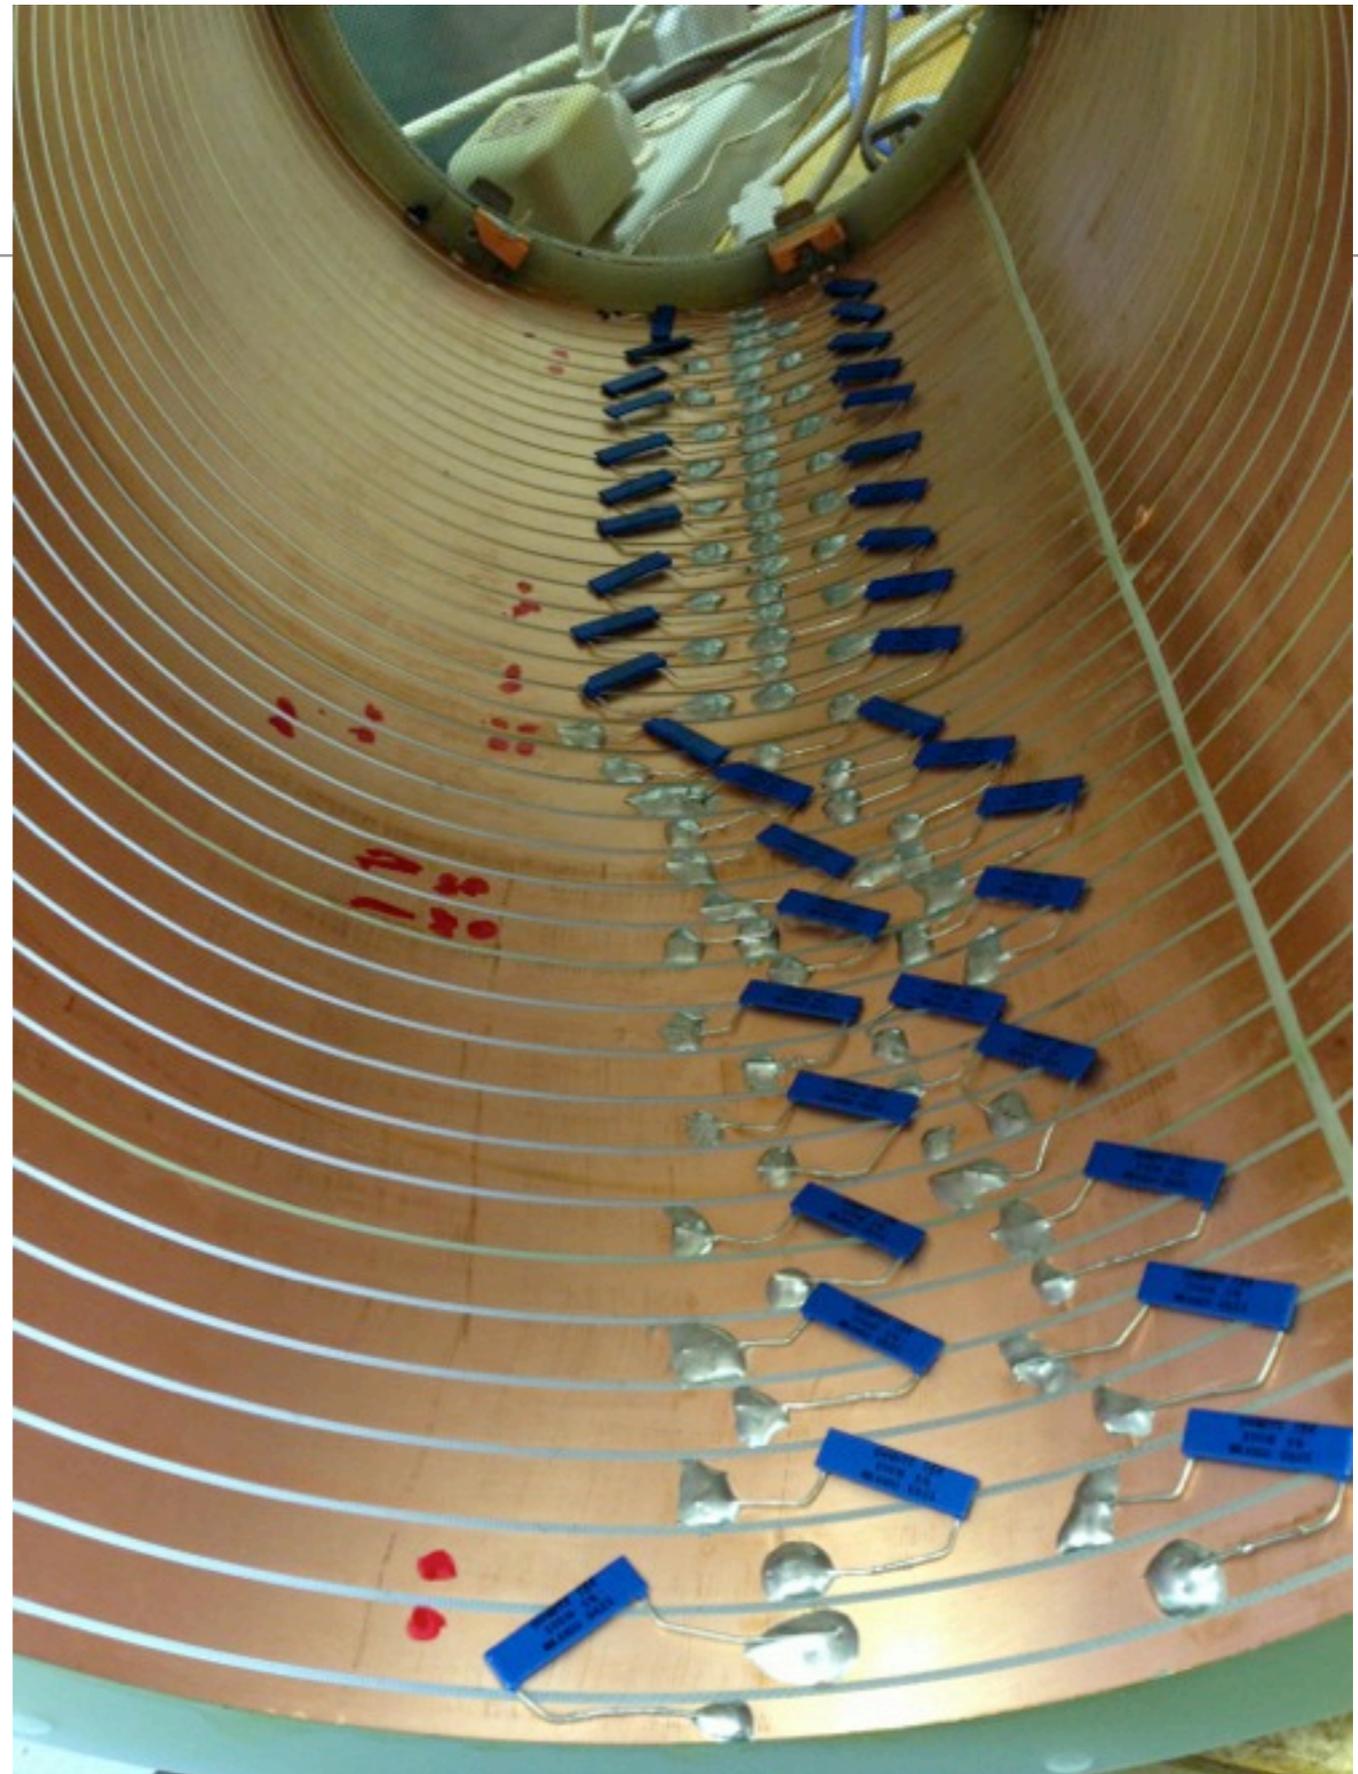
- This is the lowest section
- Red dots are failures
- **Six single resistor failures between rings** (4-5, 16-17, 19-20, 22-23, 23-24, 26-27, 38-39)
- **One double resistor failure** (open between rings 21-22)
- (Resistance between rings 27-28 was 80% of what it should be)

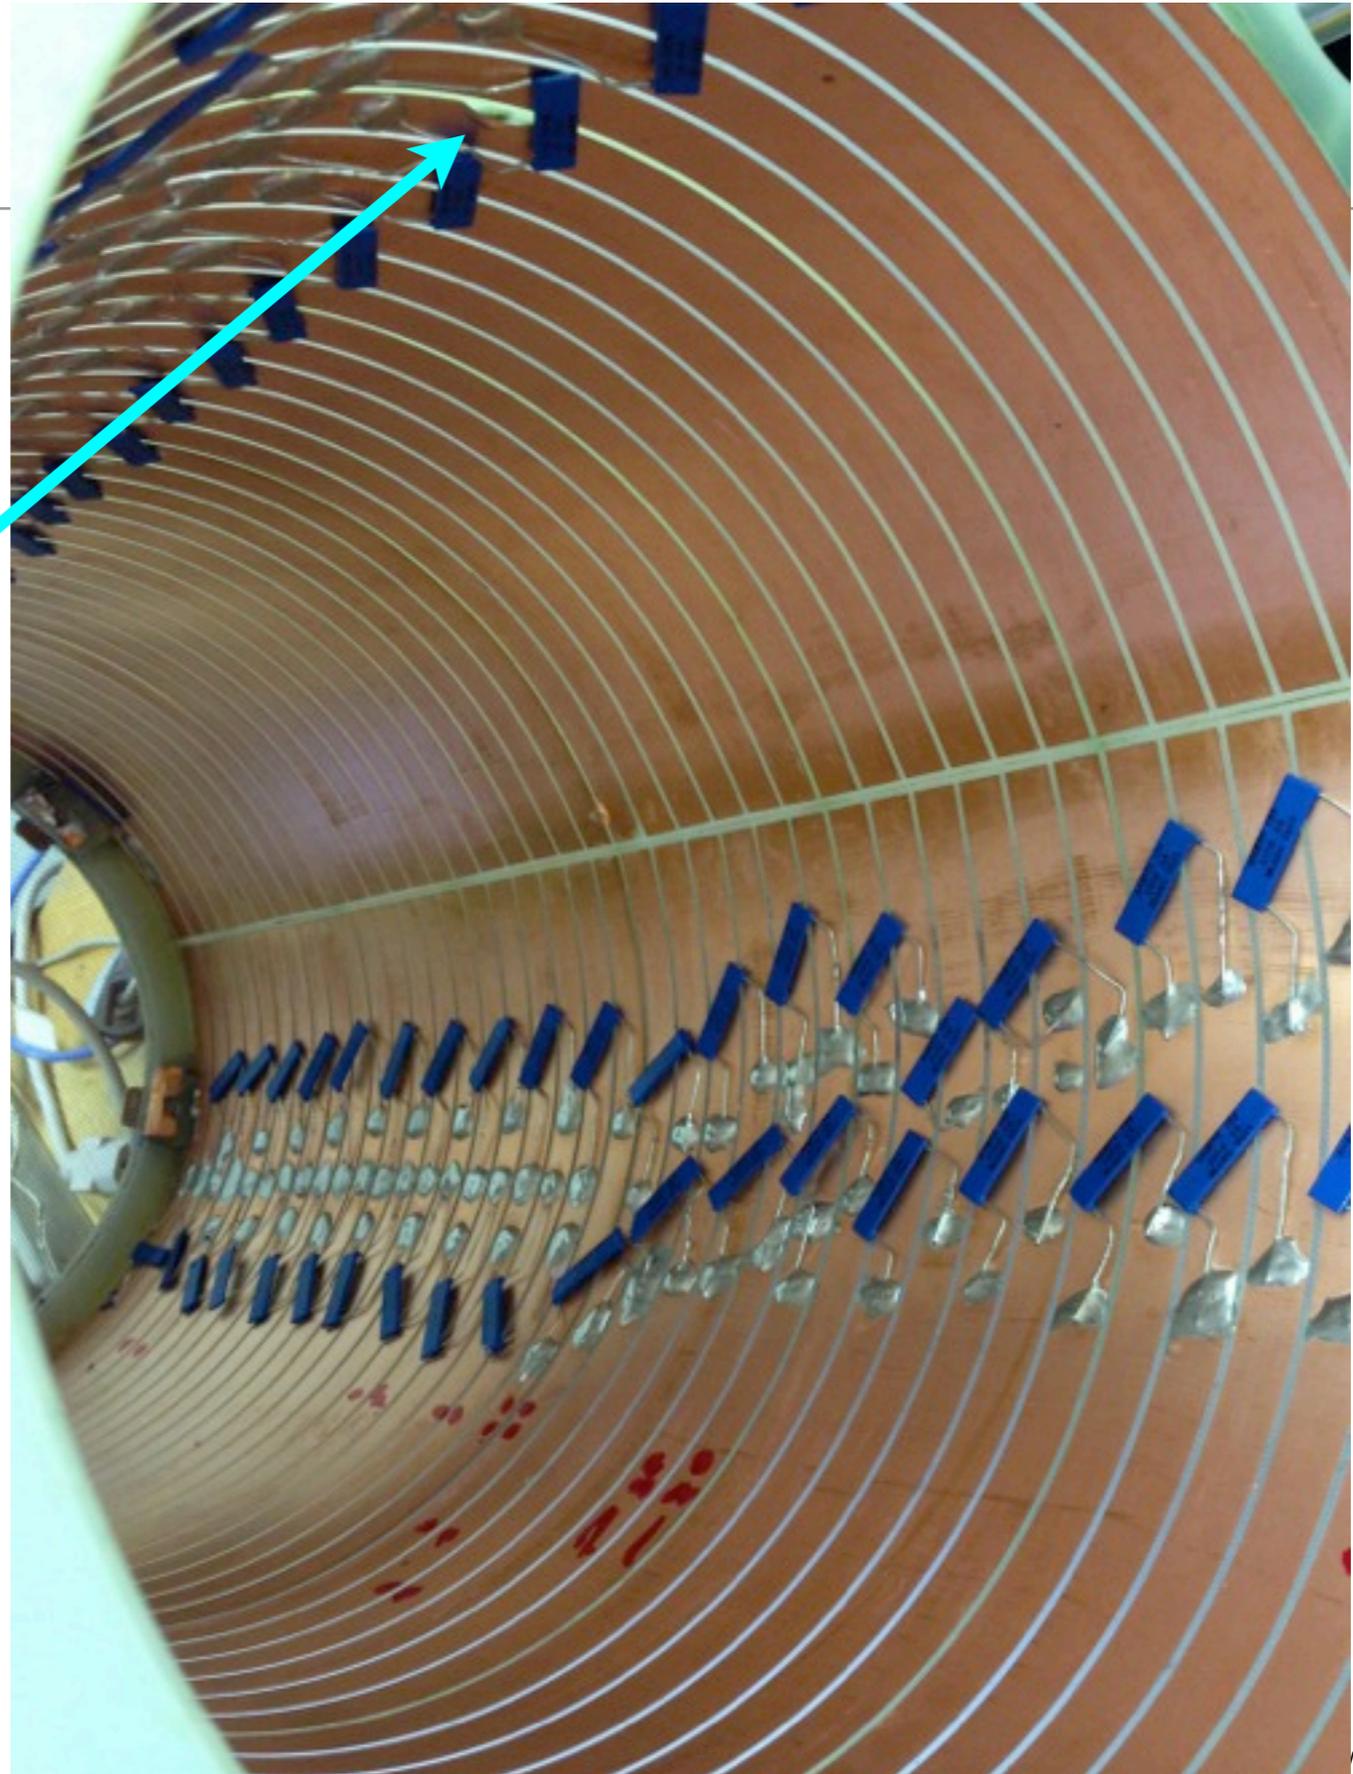
- Fail points from “Damage” slide are up here
- Those points did **not** have broken resistors on the rings

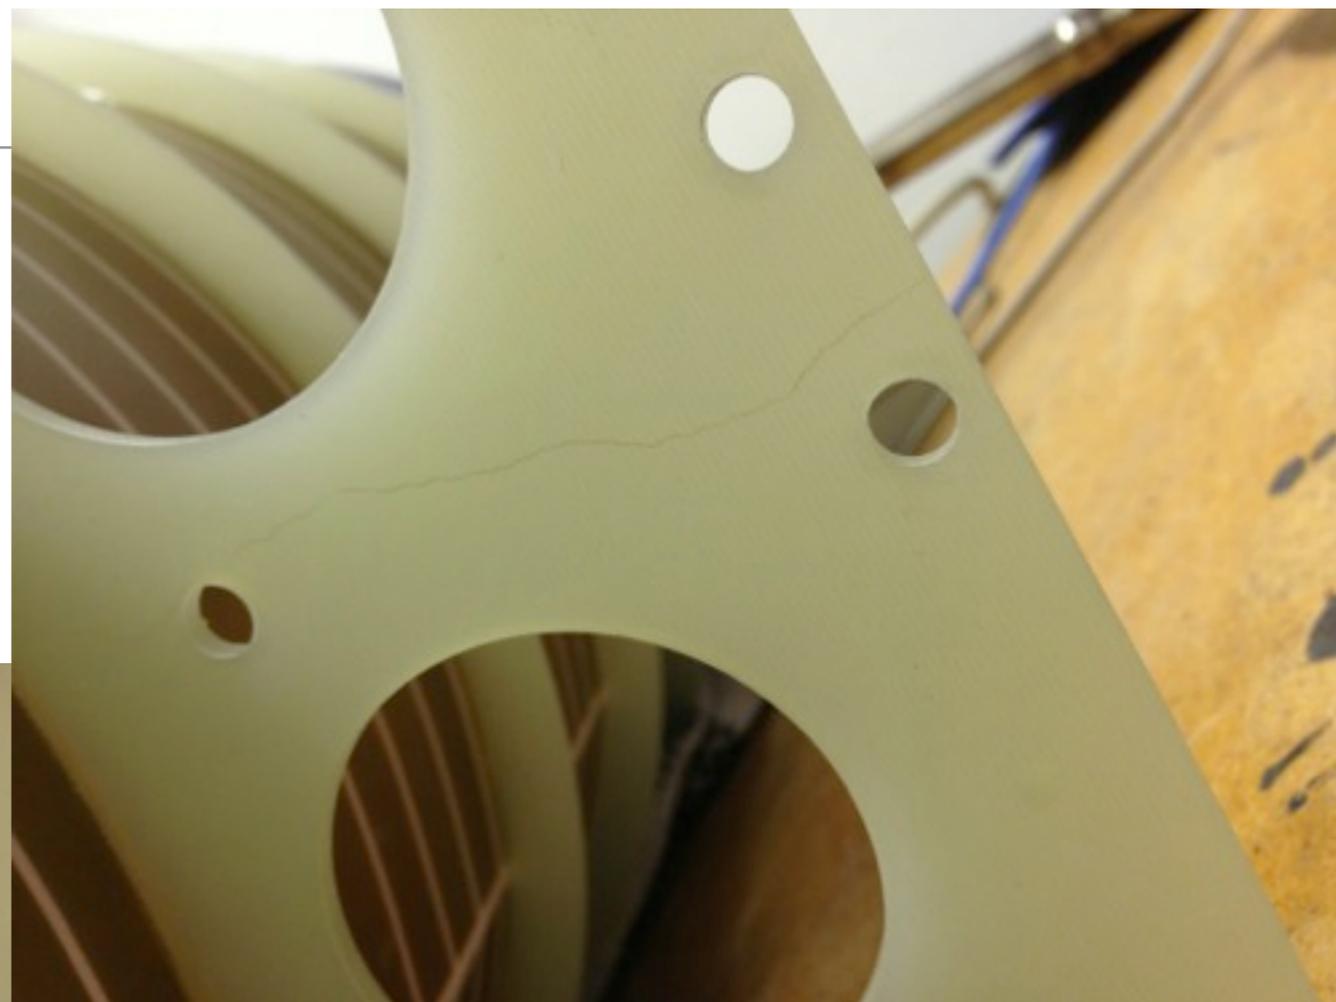
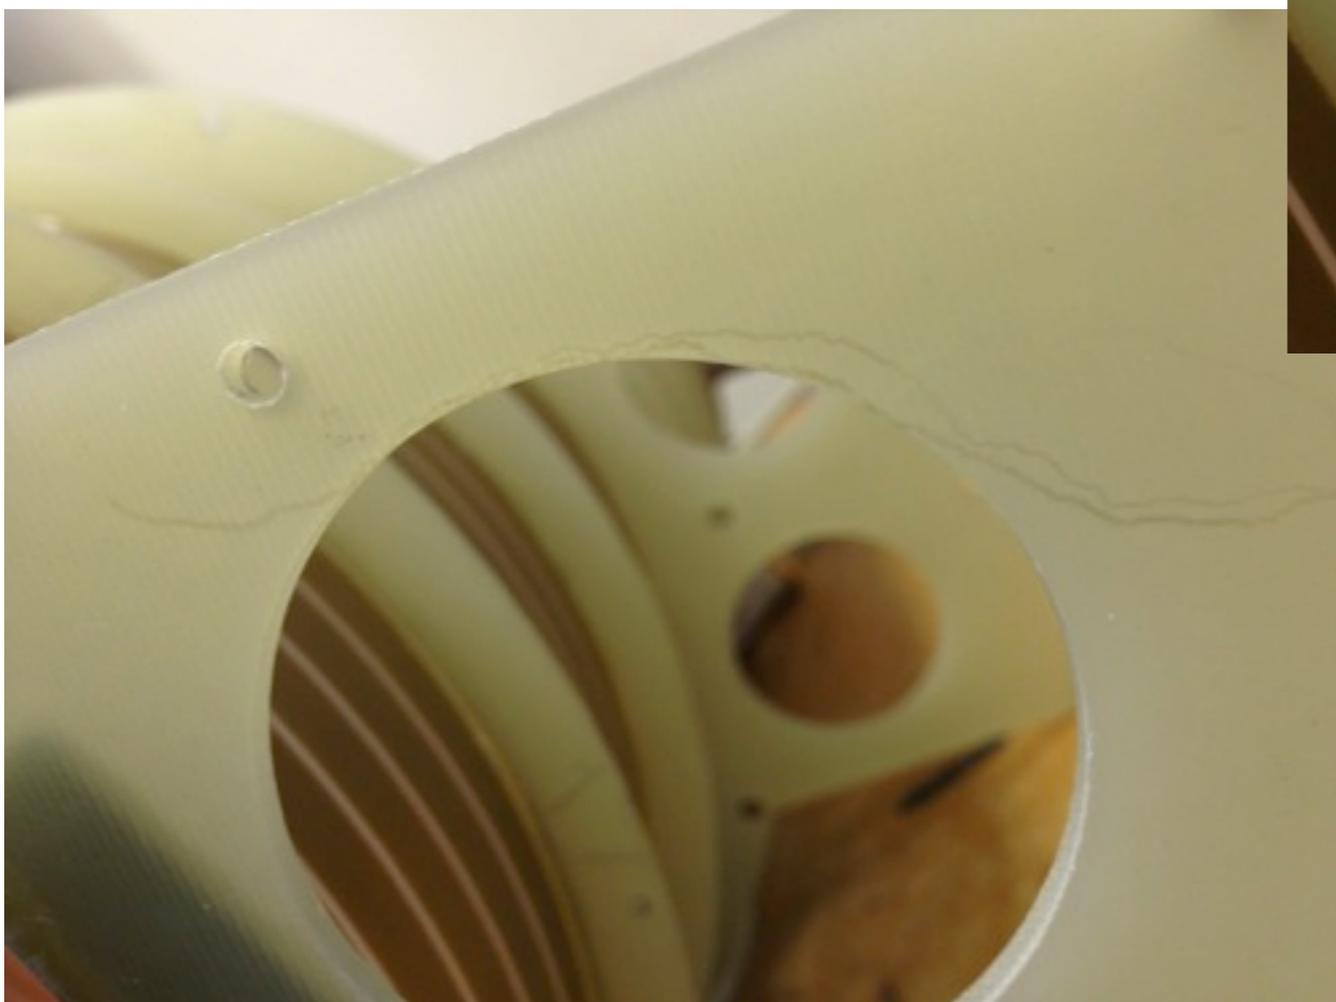
Traces on G10

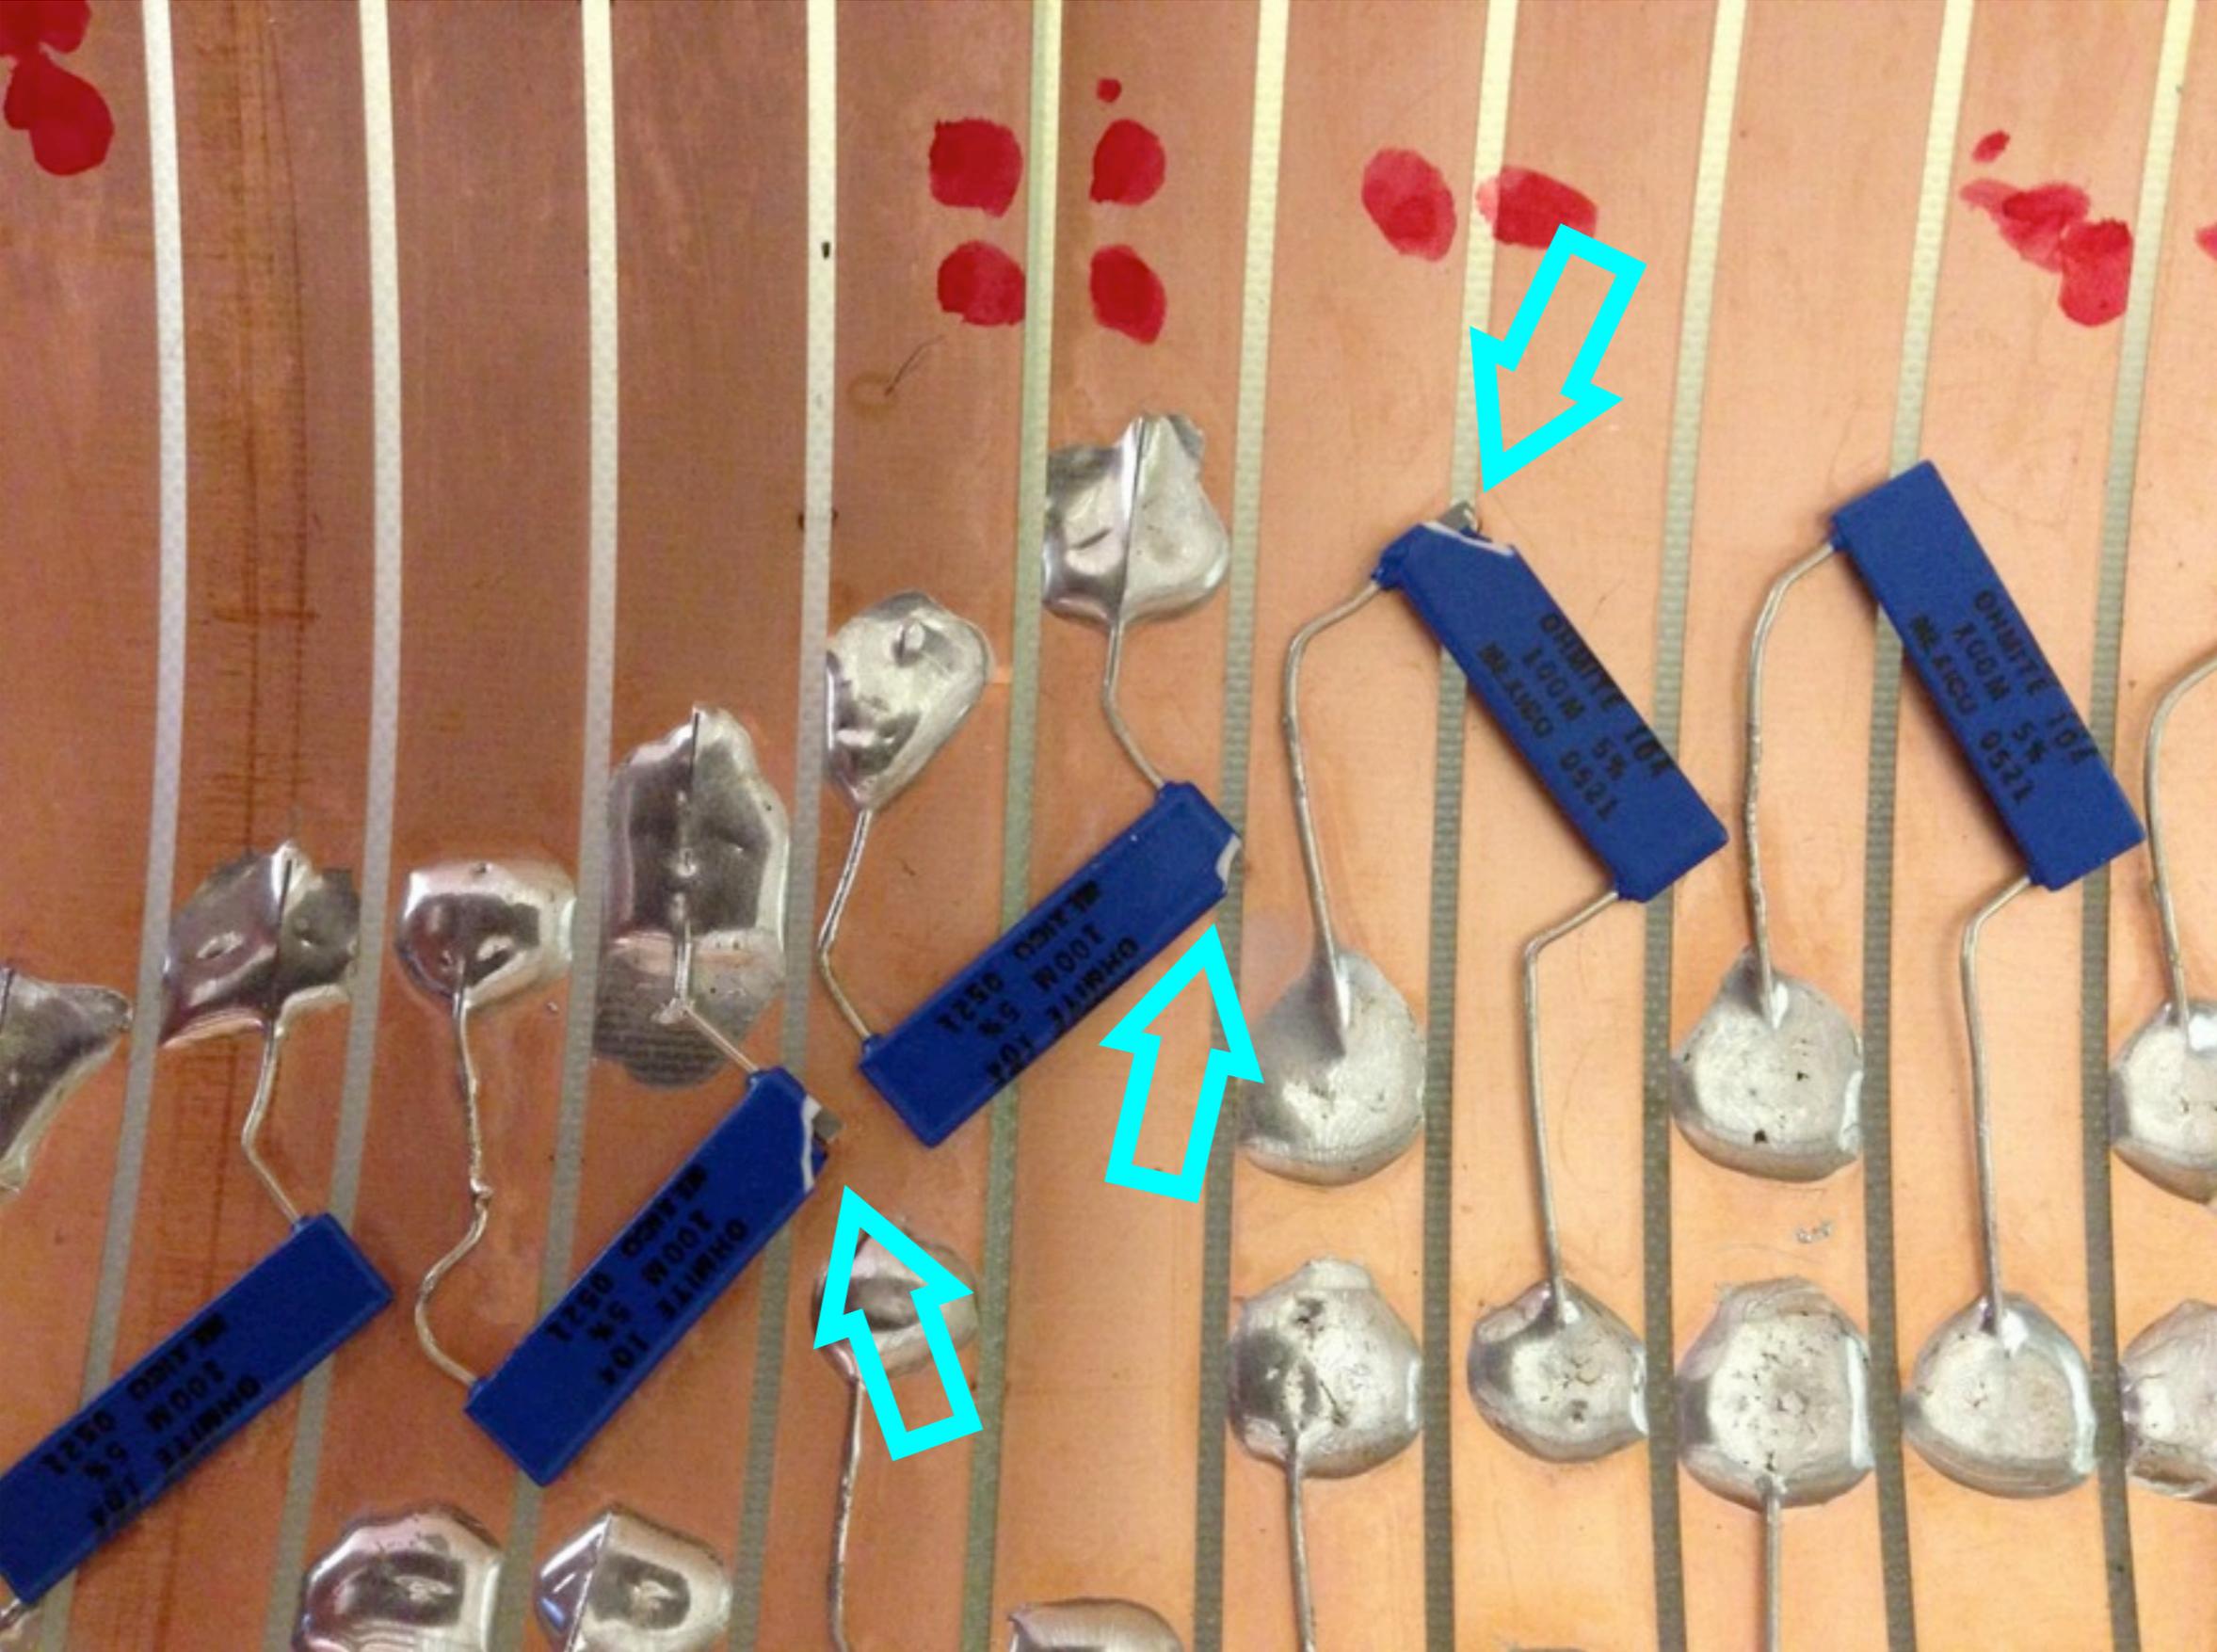
Broken Resistors:
