HV Items from Long Bo

MicroBooNE R&D Meeting
April 25, 2014

Slides by S. Lockwitz

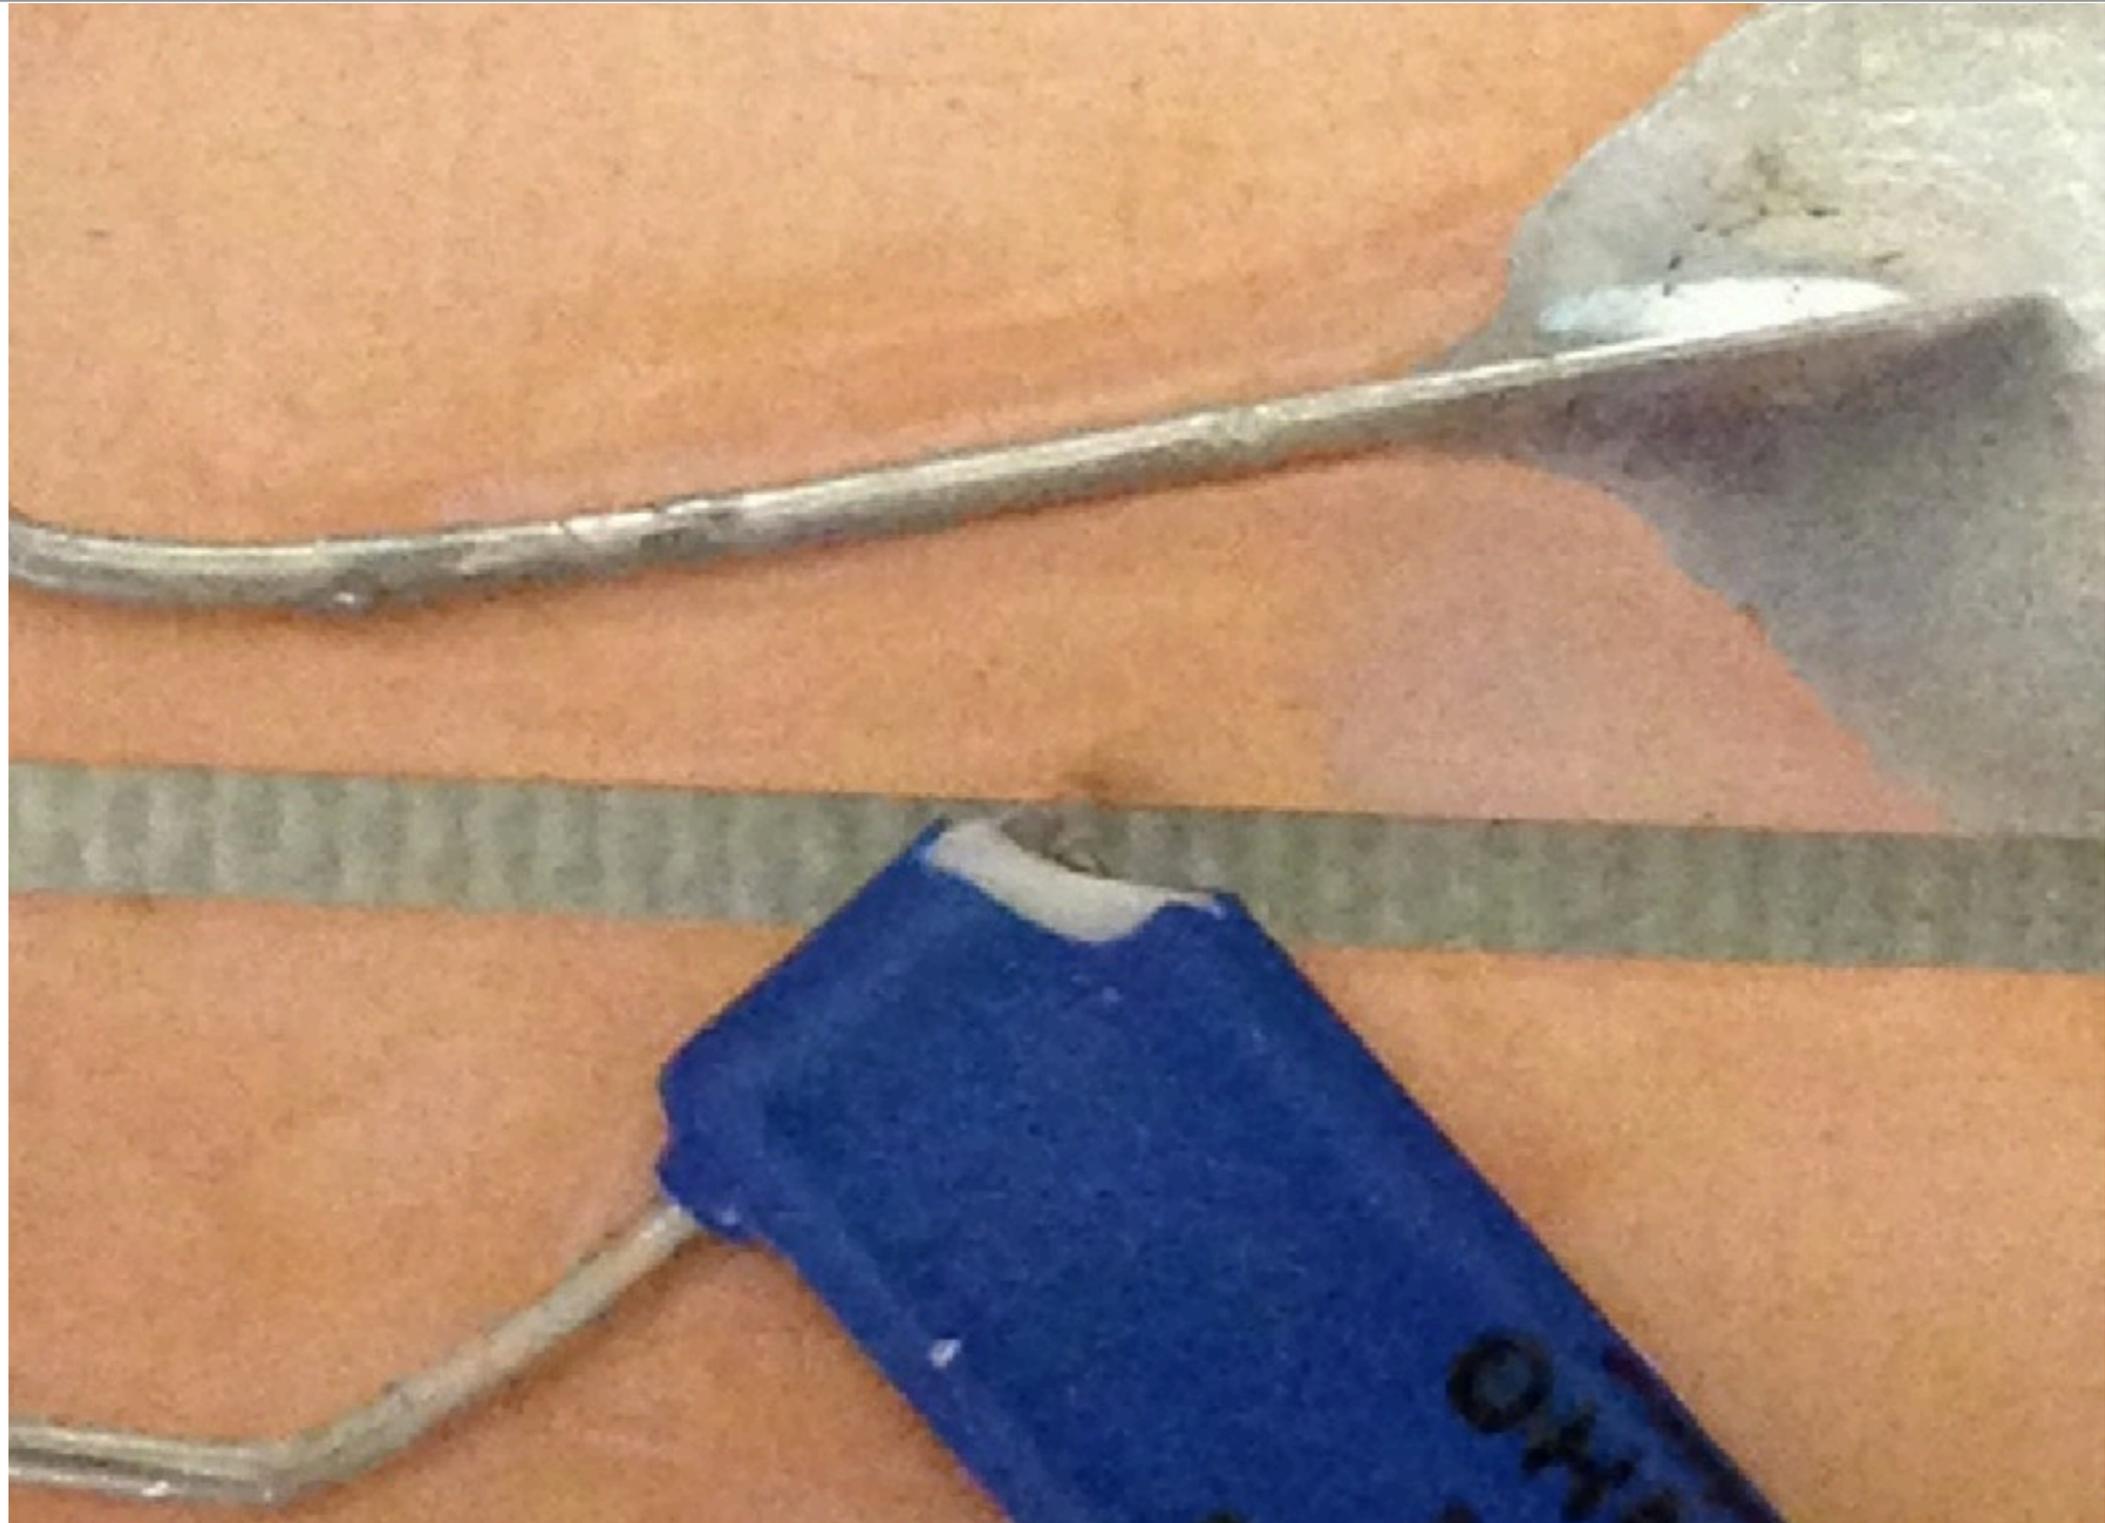
Zoom in of Middle Failure (from previous photo)
