PMT pre-commissioning tests

Gabriel Collin

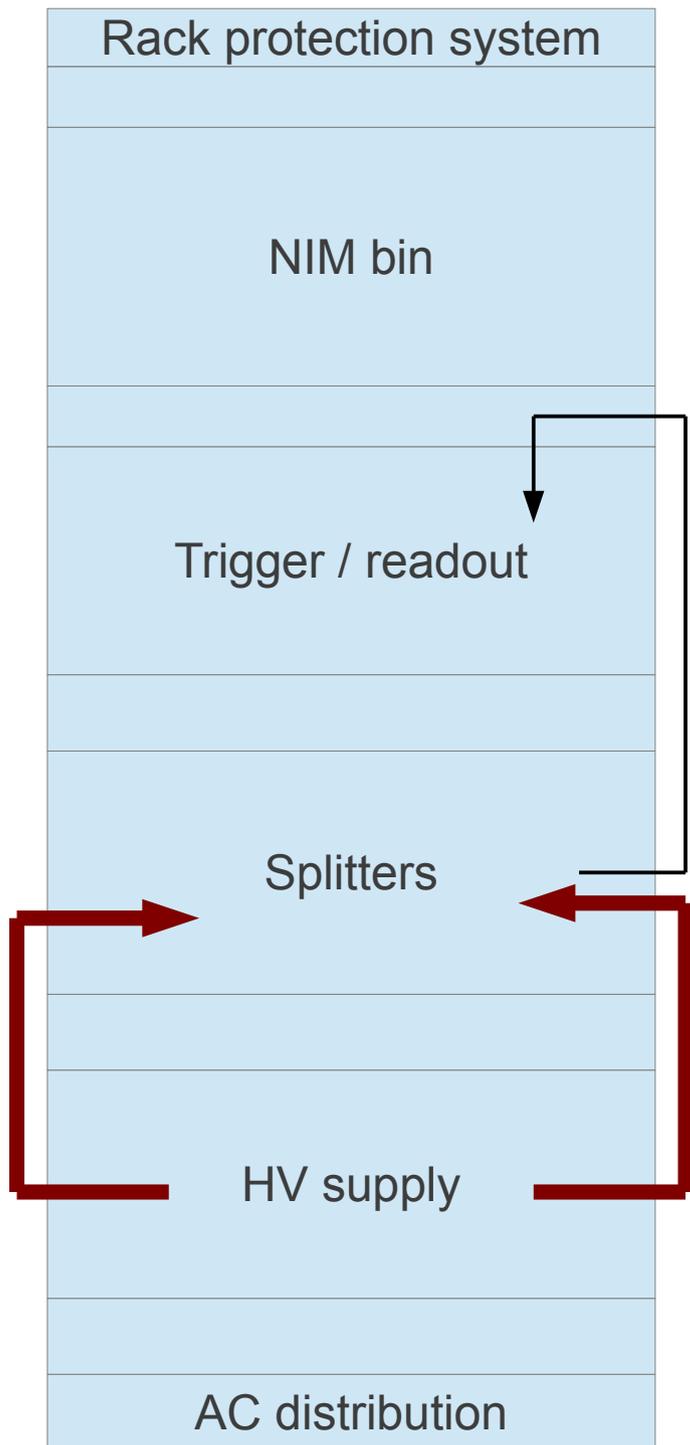
The rack

- Splitter chassis was moved from planned position (at the bottom of the rack) to just above the HV supply.
- This was made to shorten the path between the splitters and HV supply modules.

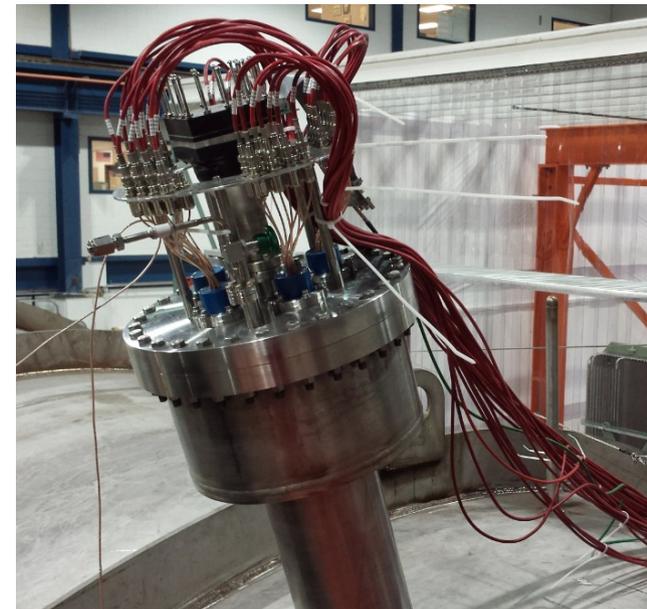
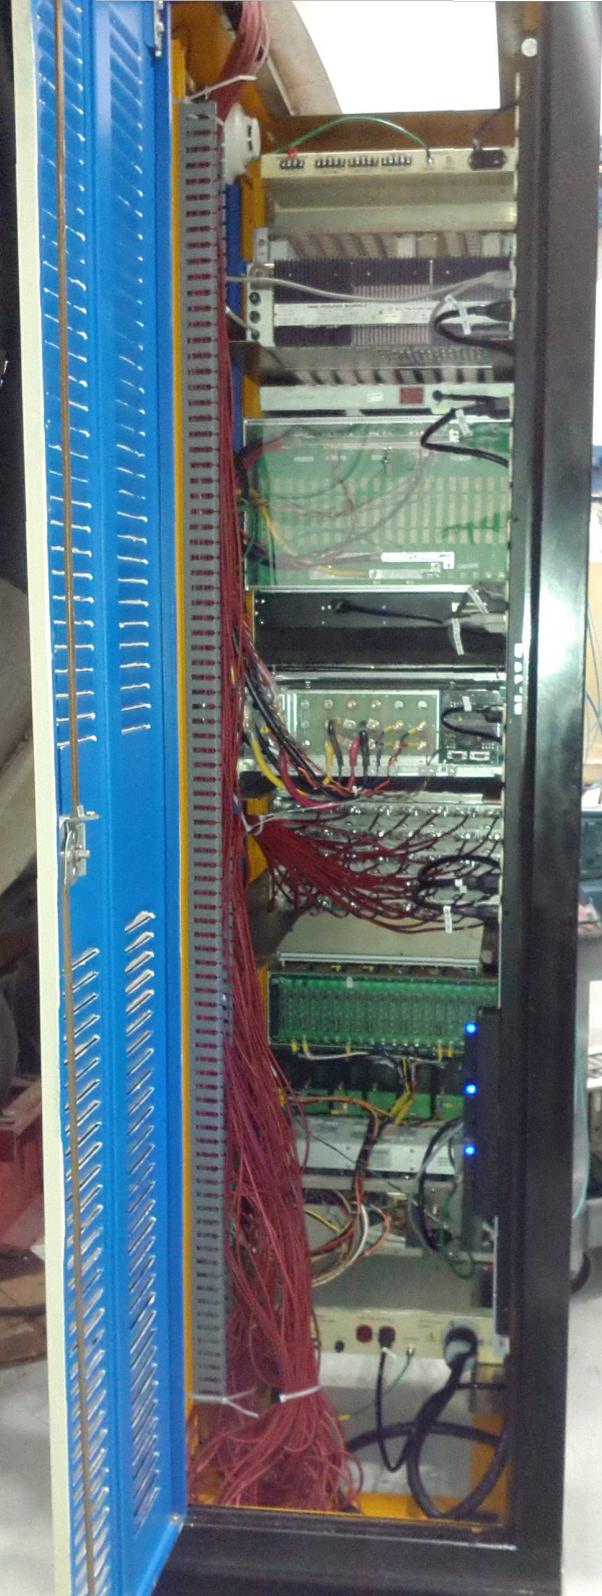
- Sowjanya sorted out the slow control GUI for the HV supply modules.
- Also found a few blown fuses on some of the motherboards and had them replaced.
- Motherboards require an interlock signal to operate.
 - This is now provided through a port on the back plane.

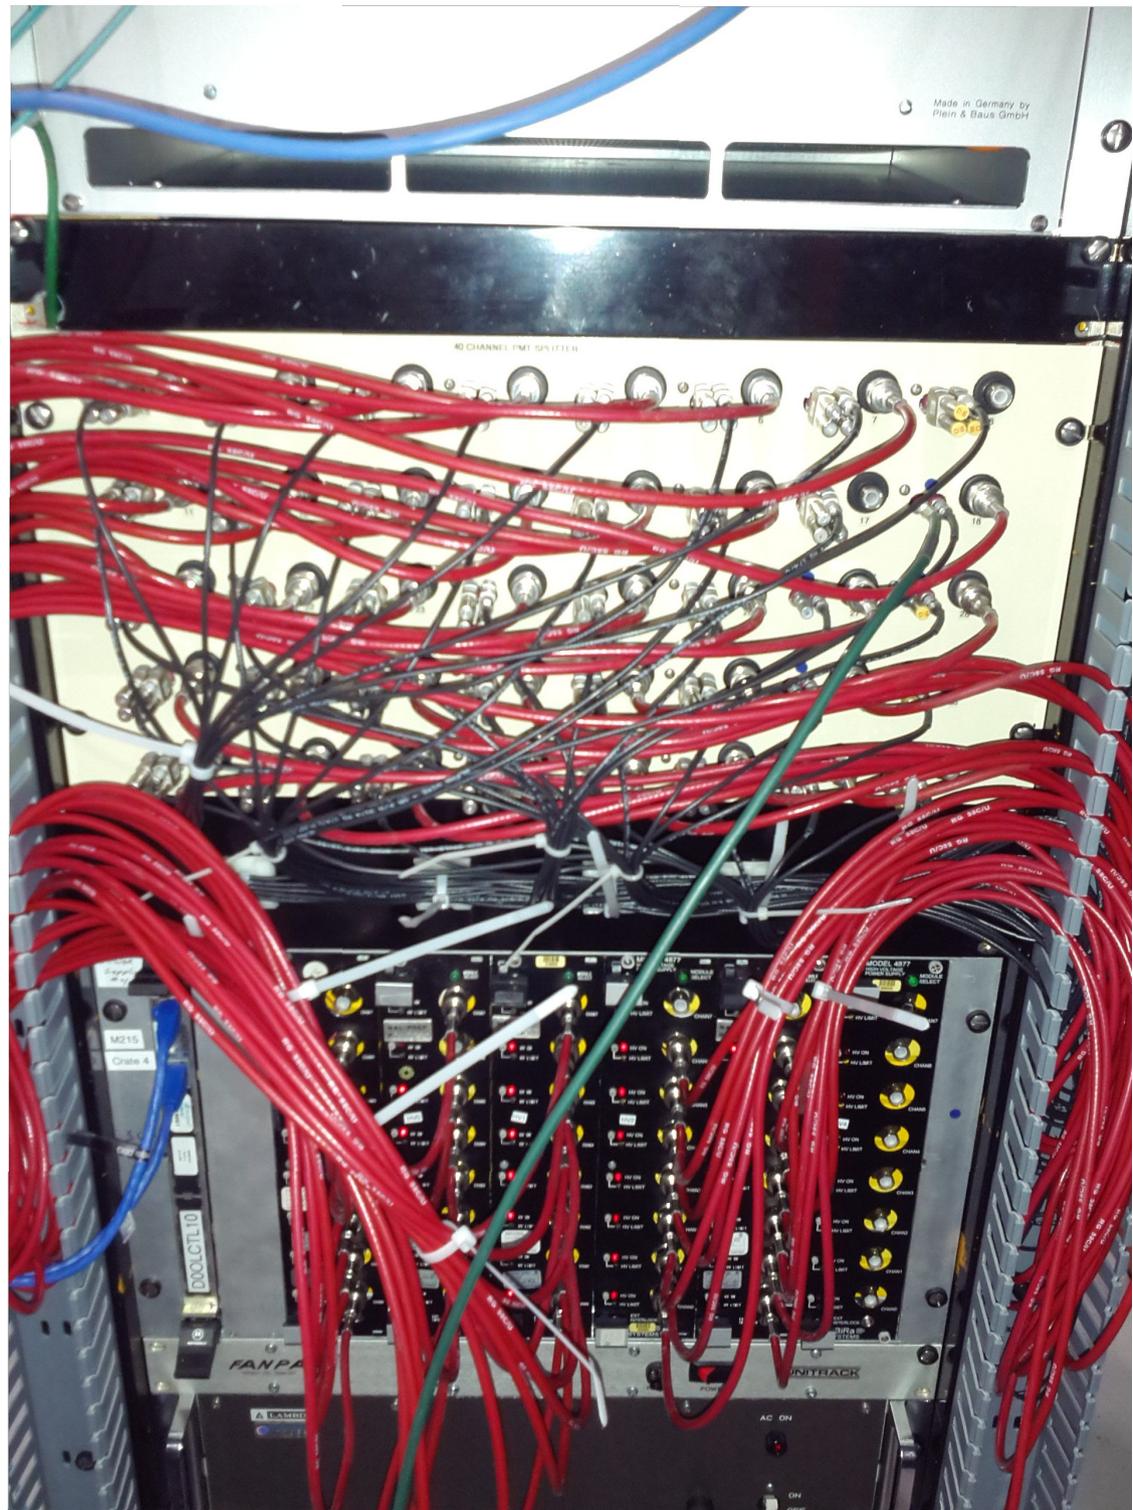
Cable routing

- Current routing situation is temporary.
 - Need to involve Linda for the final routing configuration.
