HV Update

Update on 06/26/2015 Items

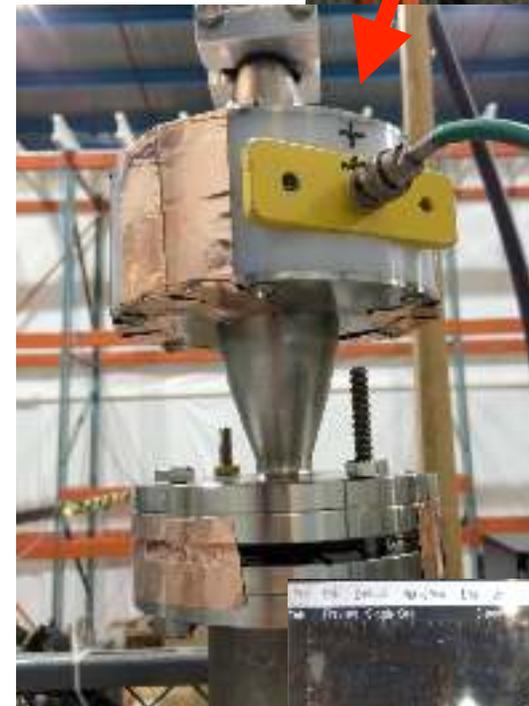
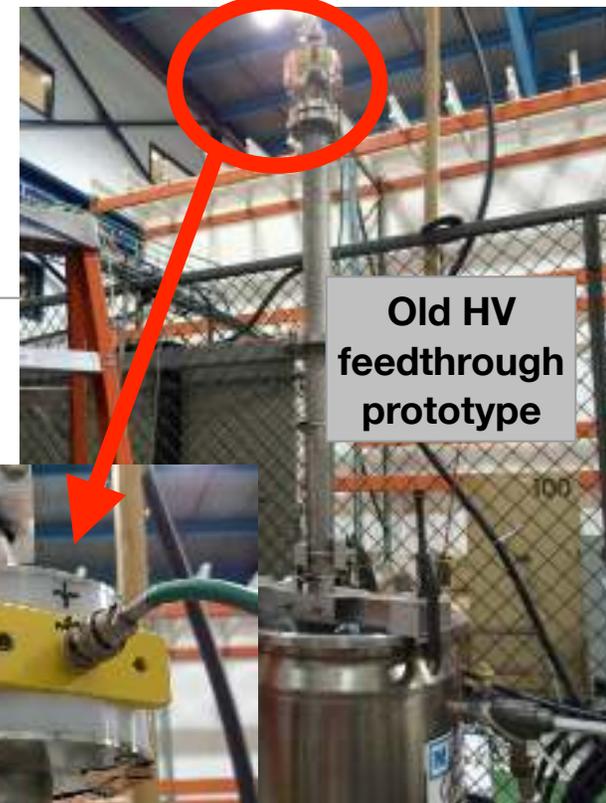
Old HV
feedthrough
prototype

- The purpose is to detect fast changes in the cable's current
 - A similar device has been used in other experiments (ICARUS) to “watch the cable relax during ramp up”
 - **We have seen no evidence of “precursors” with this or any other device**
 - The scope picture is from a discharge in air to a sharp point
 - The pulse *is* the spark
- This device fit a modified cable at D0 — it would not fit the cable we use on uB
 - I postponed getting it approved for the 10 kV ramp
 - The shop was able to fast-track the modifications needed to work at uB, and the device will now work with our cable
 - Plan to incorporate it for the 64 kV ramp

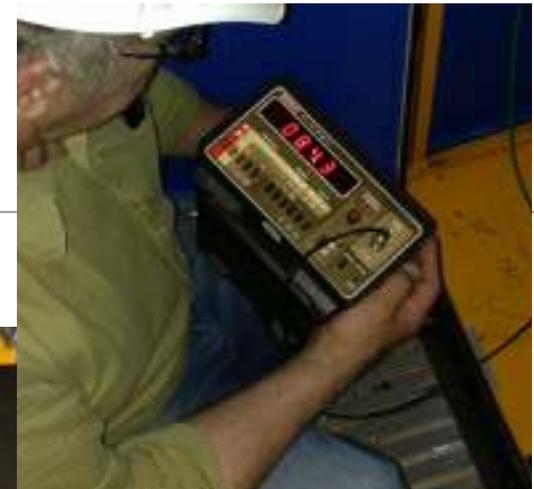
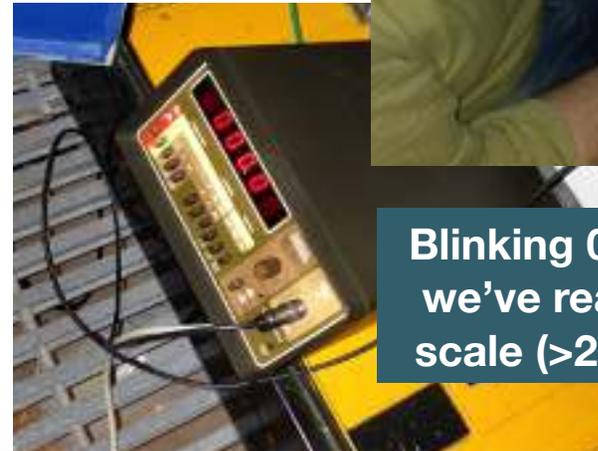
- Followed the procedure outlined in docdb 4518 for a 10 kV ramp
- Stopped at 1 kV
 - Saw differing behavior from the continuity test. Voltage at the pickoff point seemed to decay to zero
- Recreated the continuity test and saw the same behavior
- Stopped the test
- Got Walter to measure the resistance from the feedthrough cable to ground —> Appeared open
- Walter then measured the capacitance, and there was evidence that the disconnect was at the feedthrough/cathode connection
 - Measured 1 nF

Blinking 000 means we've reached full scale (>200 GOhm)

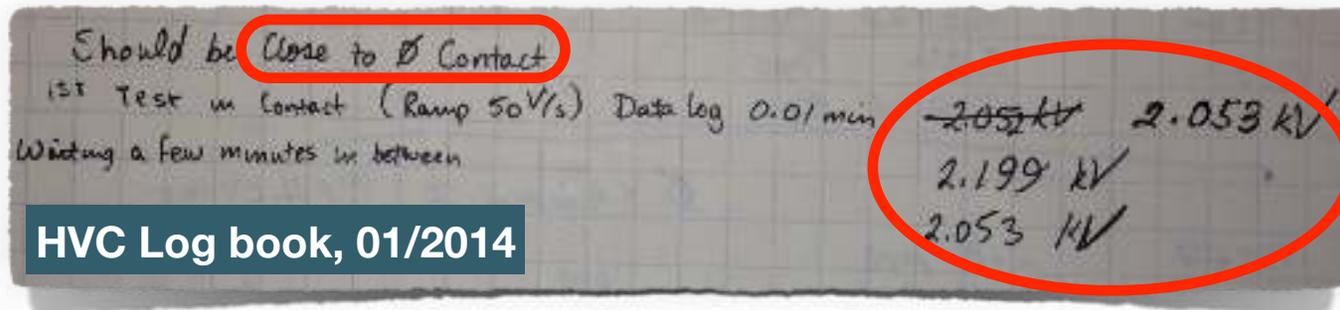
- We had seen a non-zero conduction value for conductors in contact before:

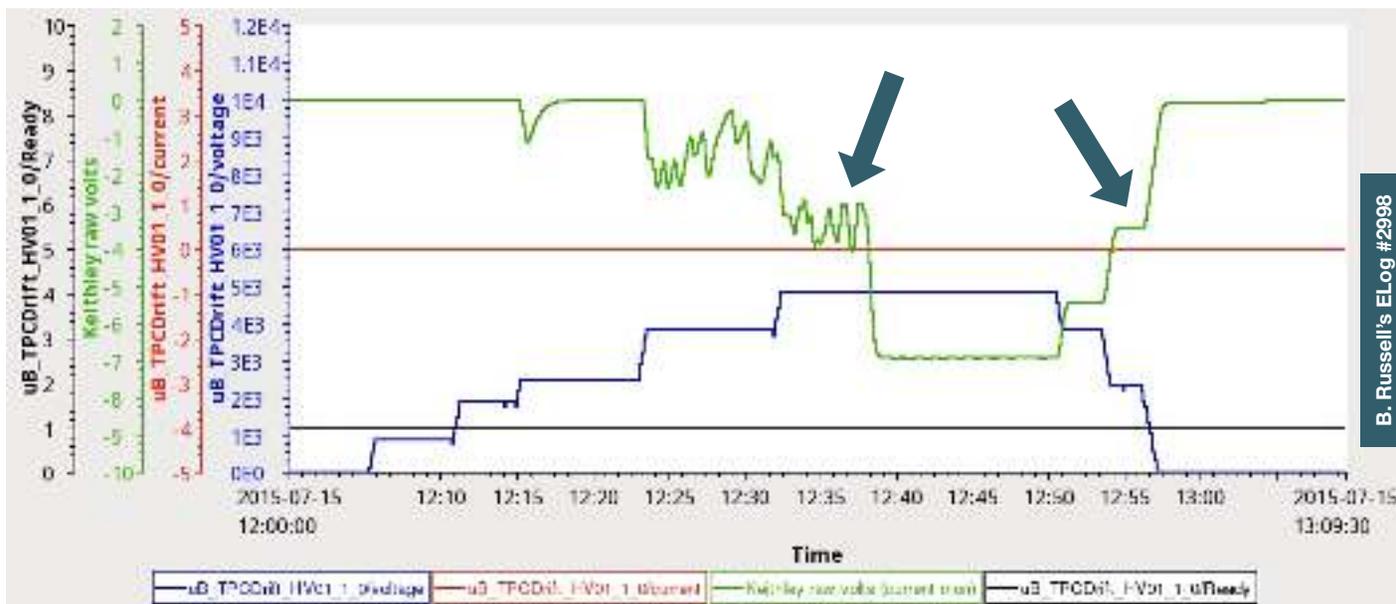
- Discussed with the commissioning leaders and team and decided to go to 5 kV
- Saw non-constant voltage values at the pick off point until we were stable at 5 kV.
