HV Items from Long Bo

MicroBooNE R&D Meeting
April 25, 2014

Slides by S. Lockwitz

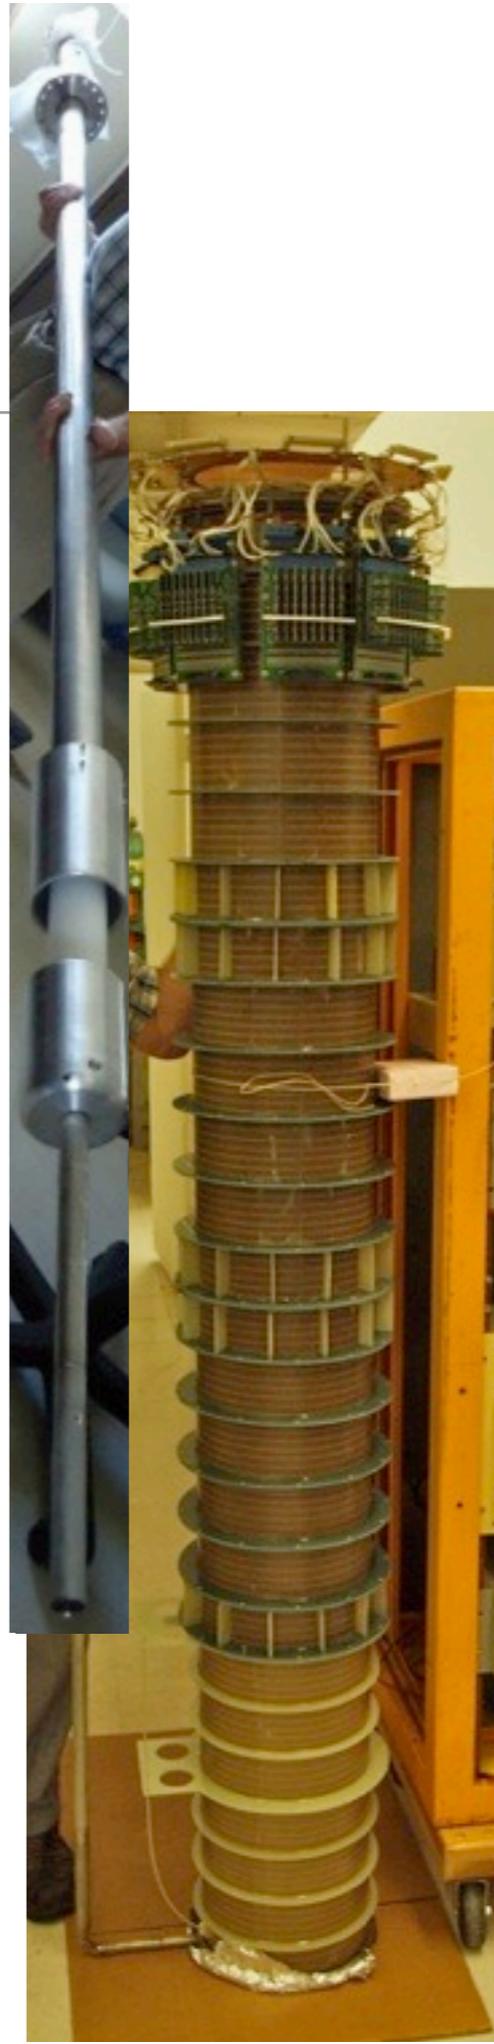
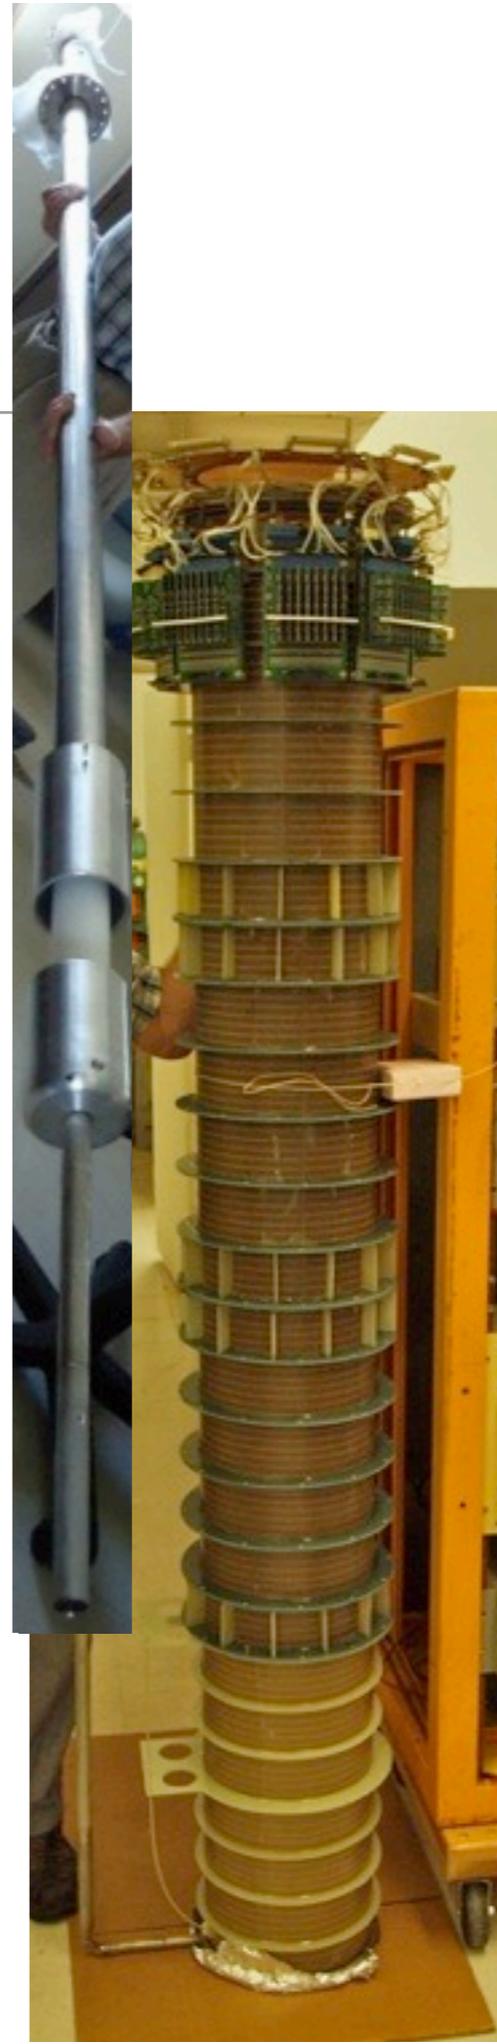
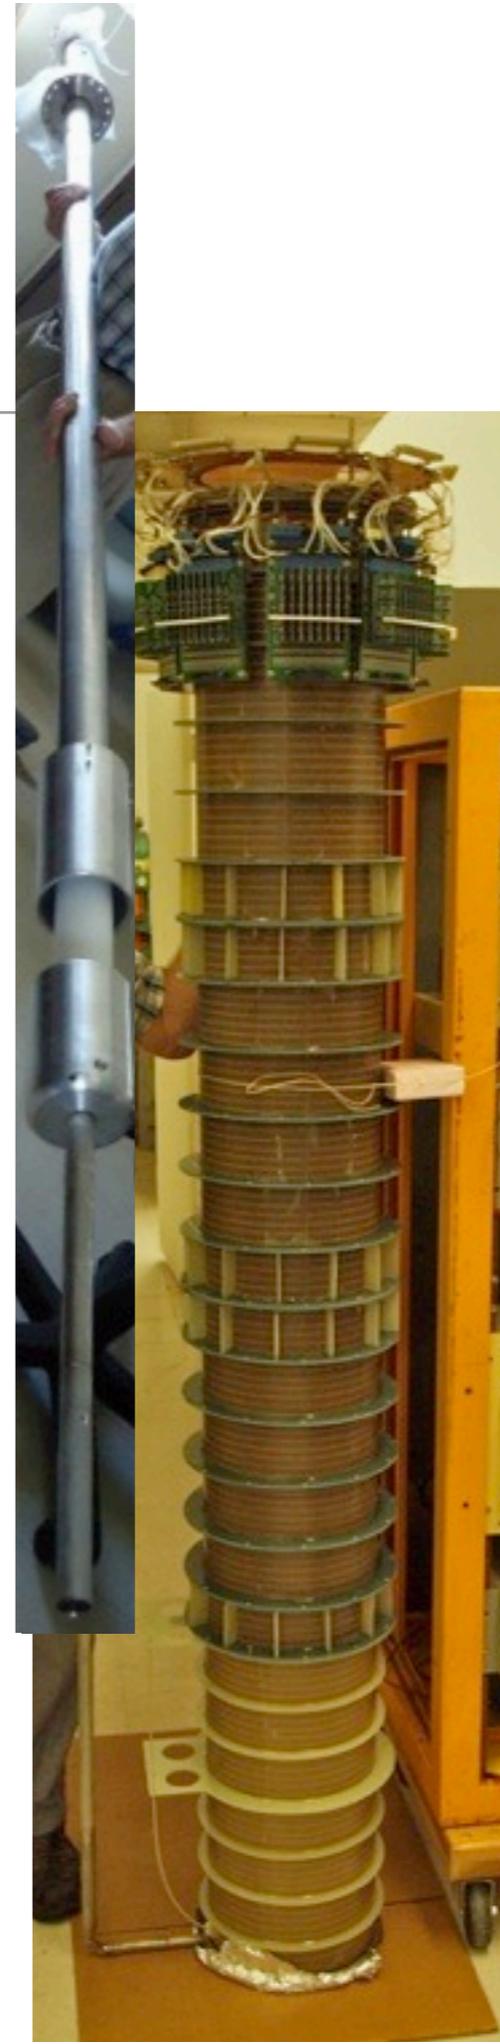
- We had a problem with Long Bo HV

- We had a problem with Long Bo HV
- There was an incident the first time it was turned on (not the fault of the HV)

- We had a problem with Long Bo HV
- There was an incident the first time it was turned on (not the fault of the HV)
- The HV never held 100 kV for more than a few seconds after that

- We had a problem with Long Bo HV
- There was an incident the first time it was turned on (not the fault of the HV)
- The HV never held 100 kV for more than a few seconds after that
- We operated at lower voltages but still saw a trip every day or so

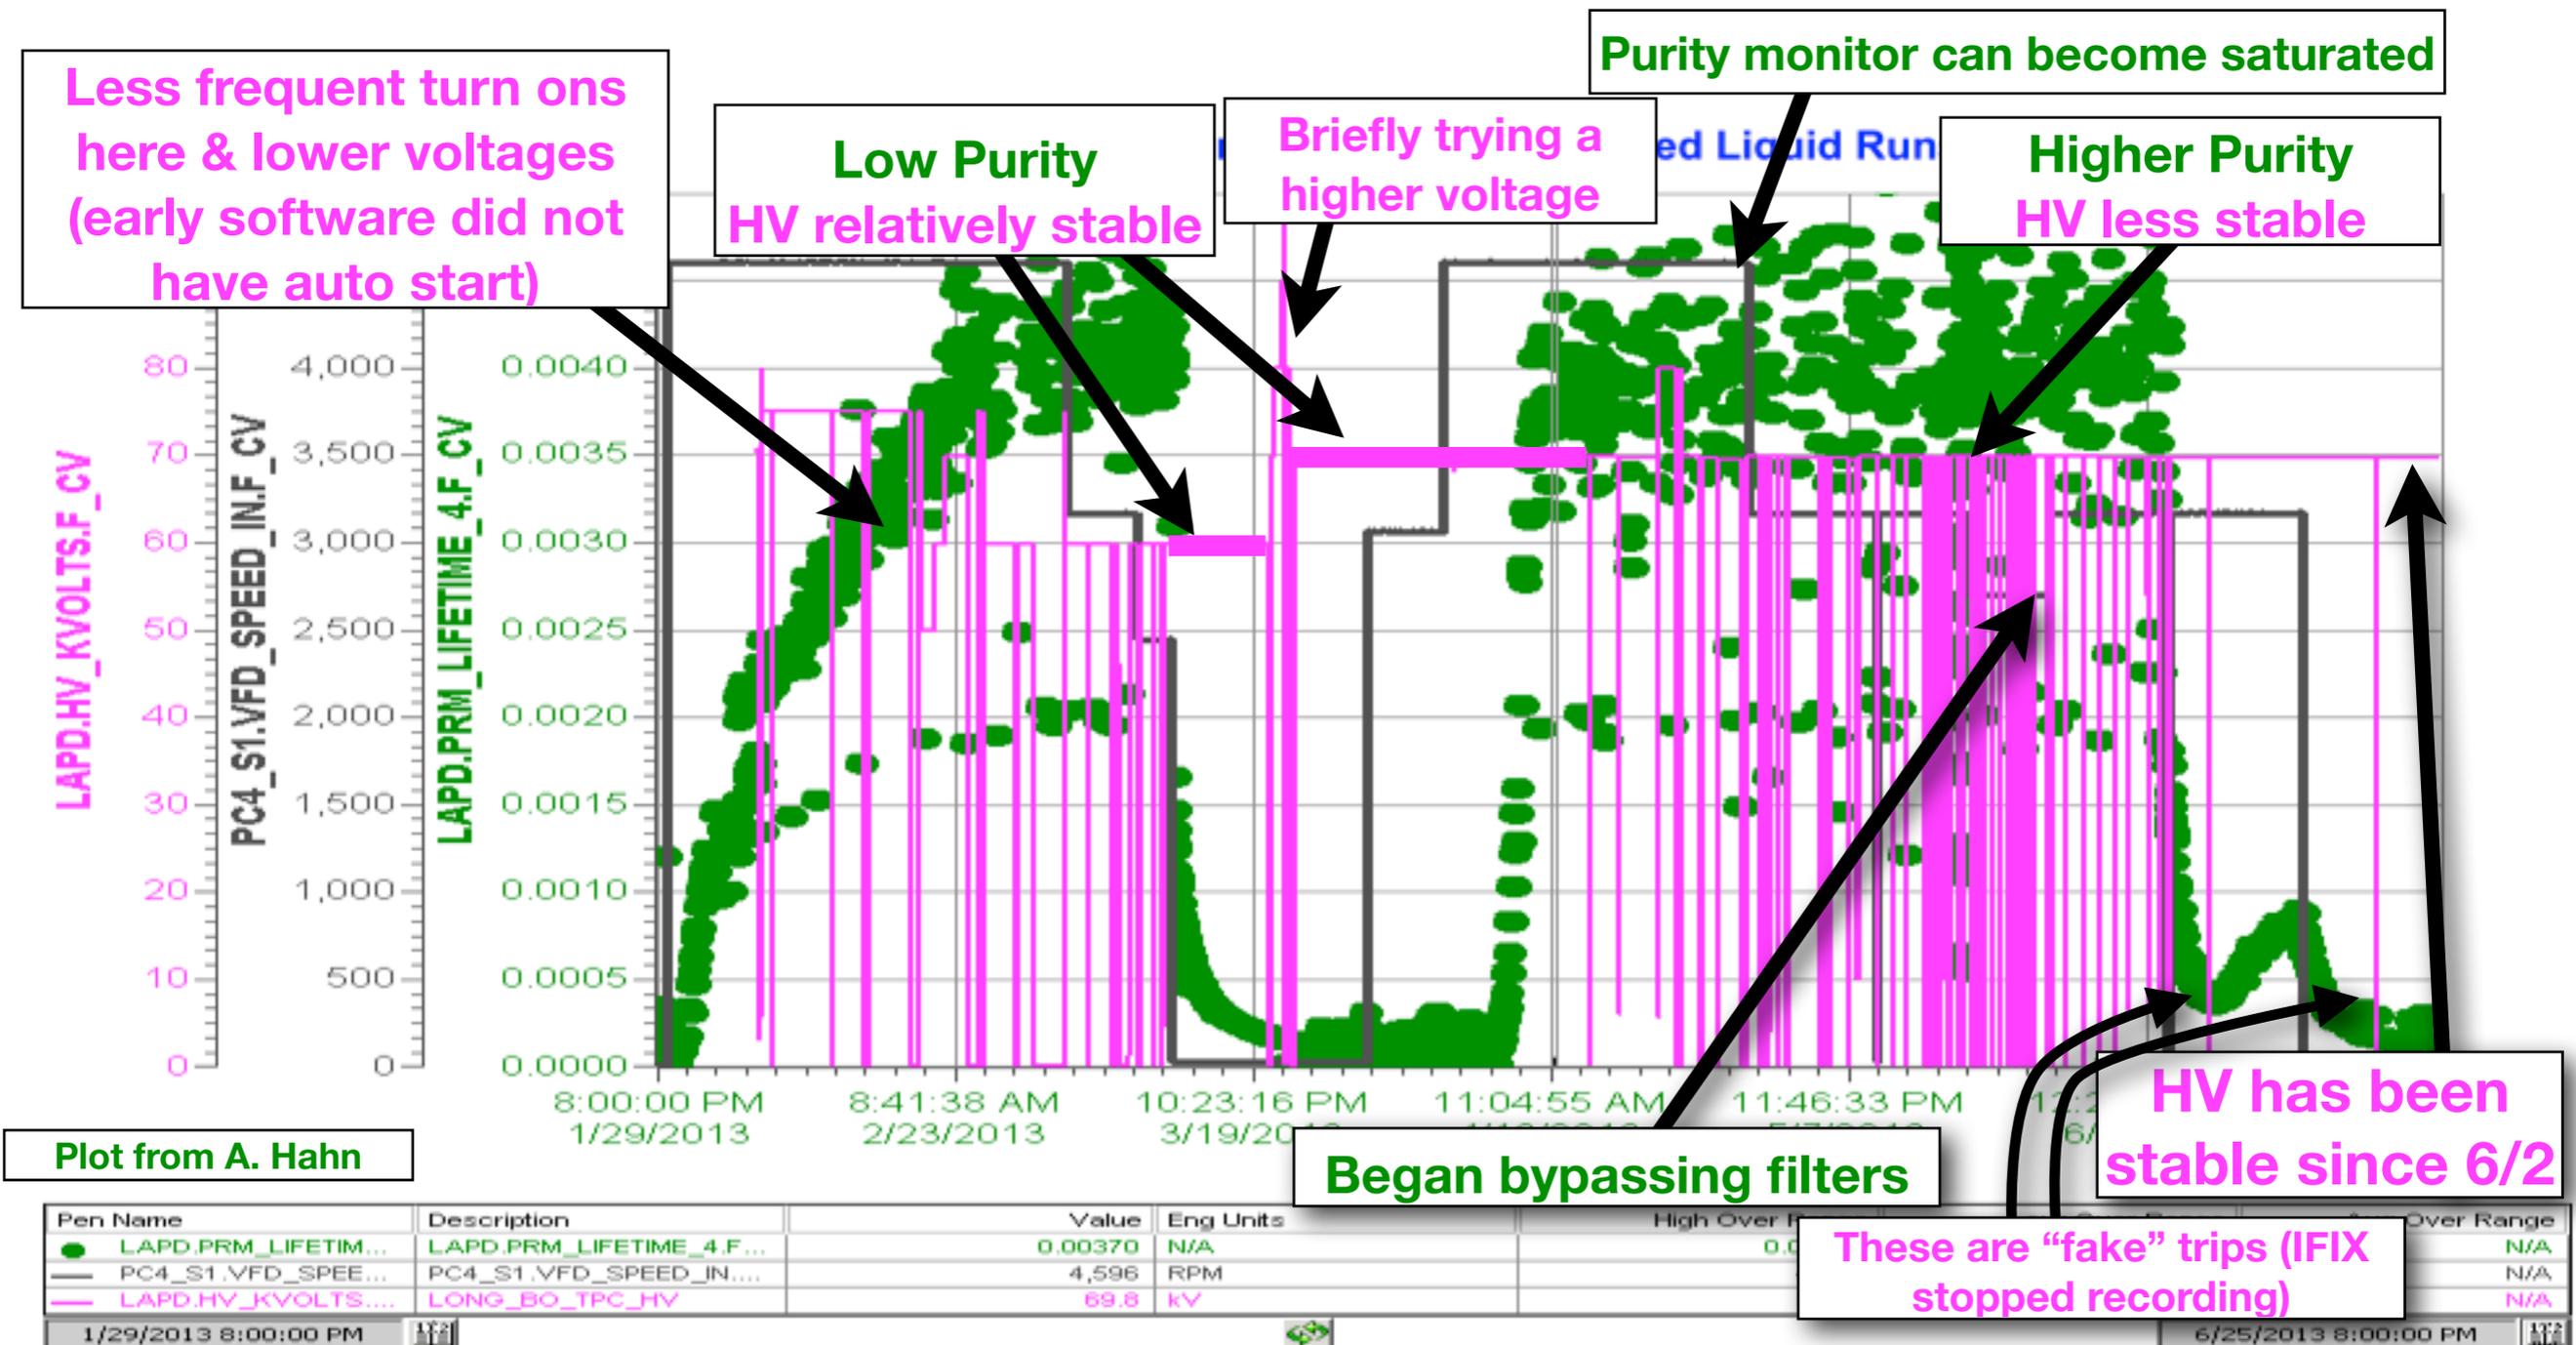
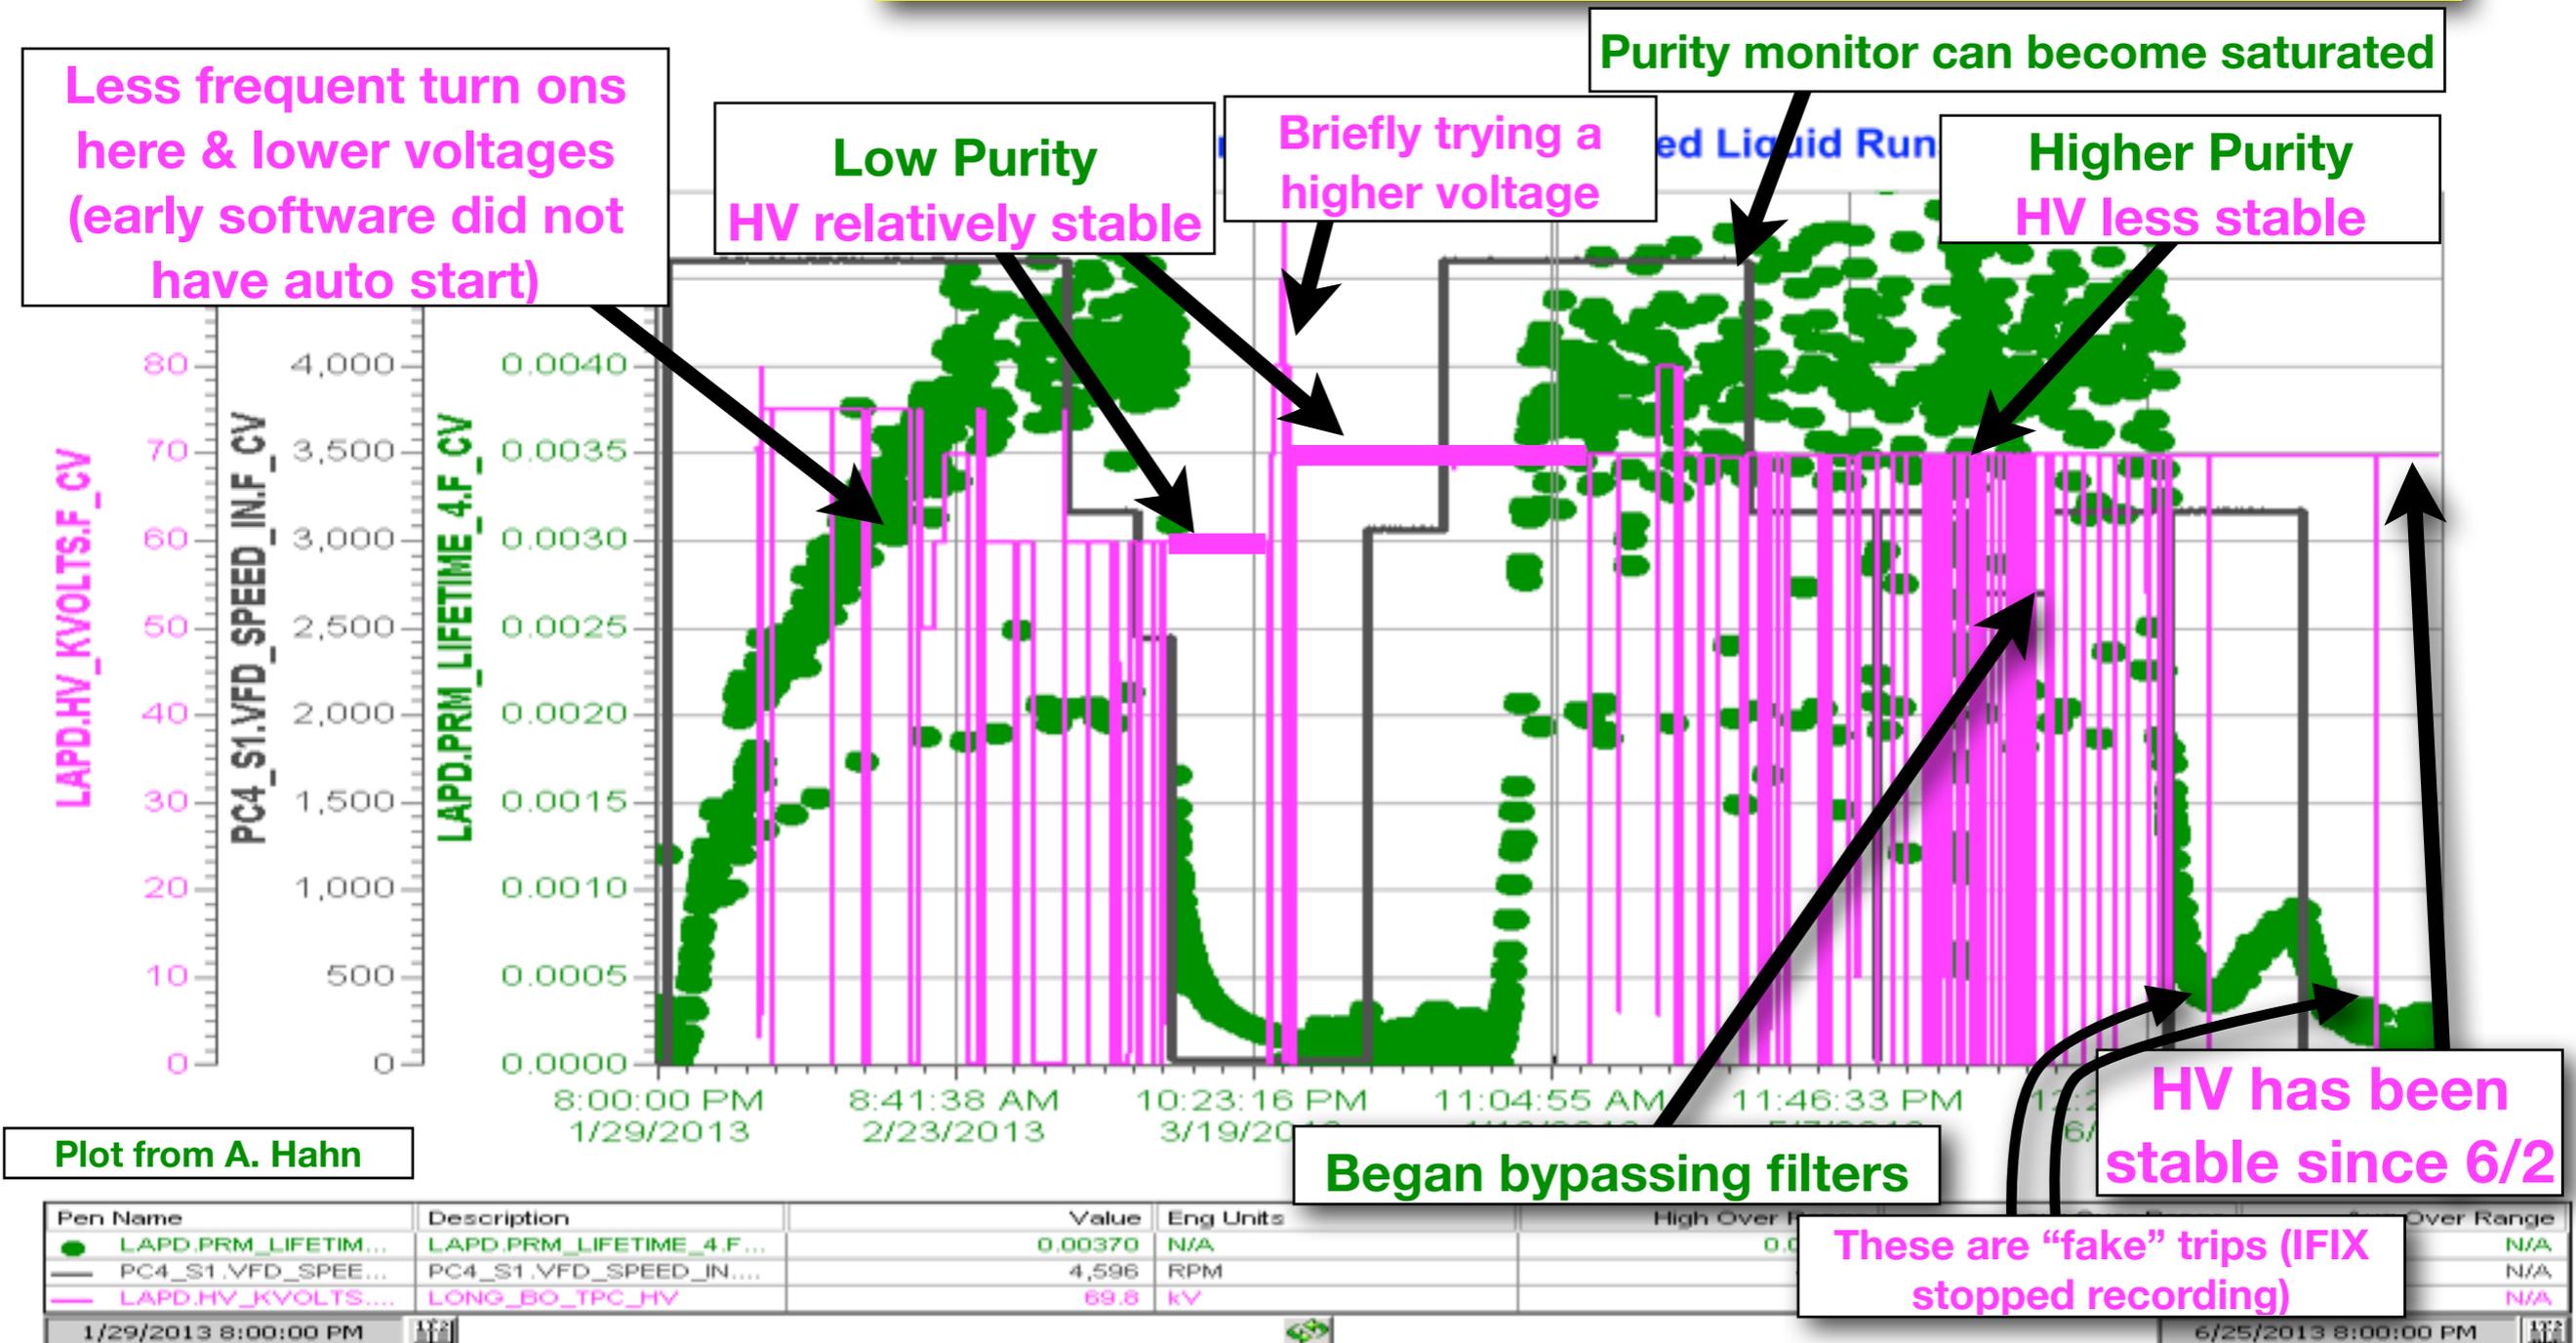
- After a pump failure, we noted HV stability
- We eventually determined the HV stability is related to the purity of the LAr

- After a pump failure, we noted HV stability
- We eventually determined **the HV stability is related to the purity of the LAr**

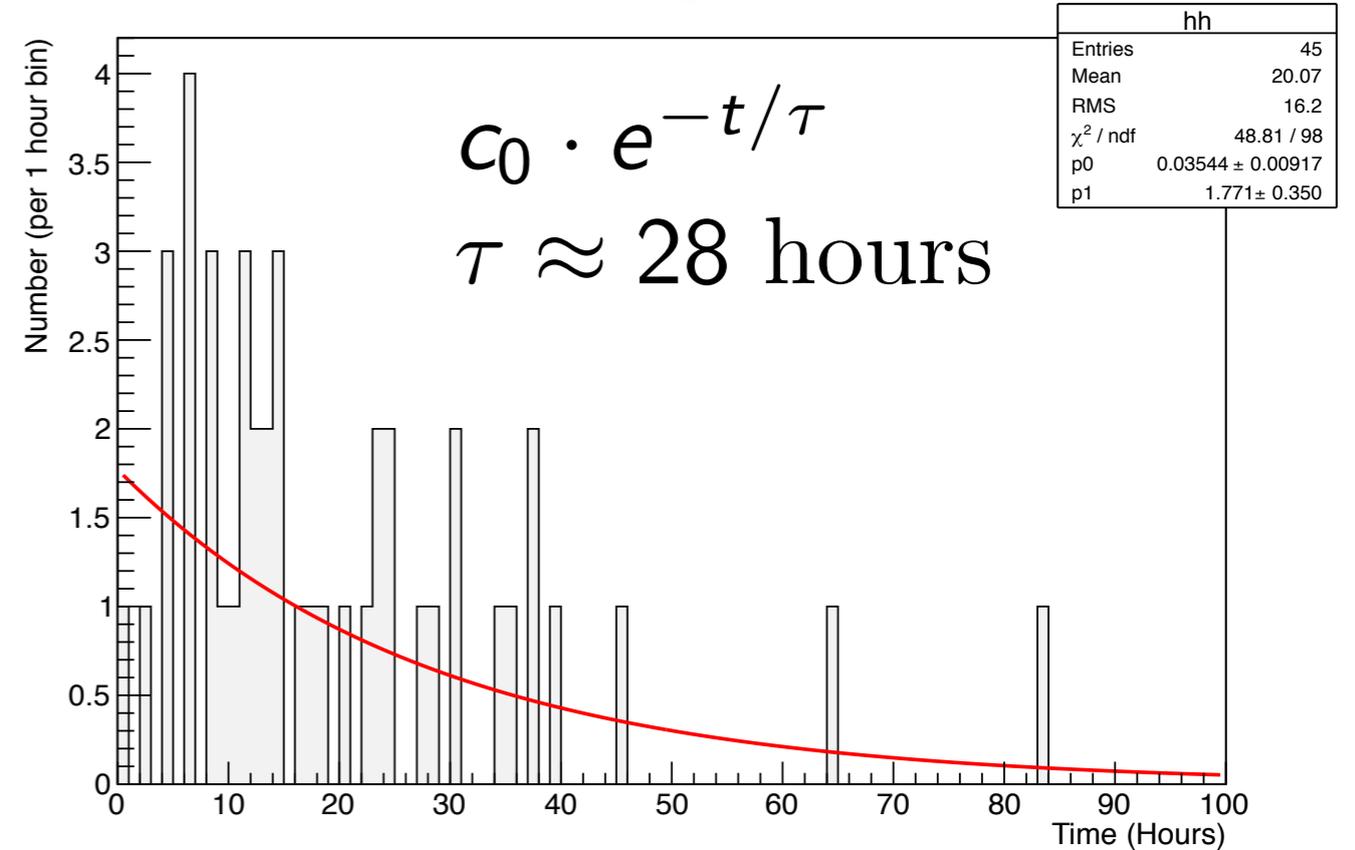
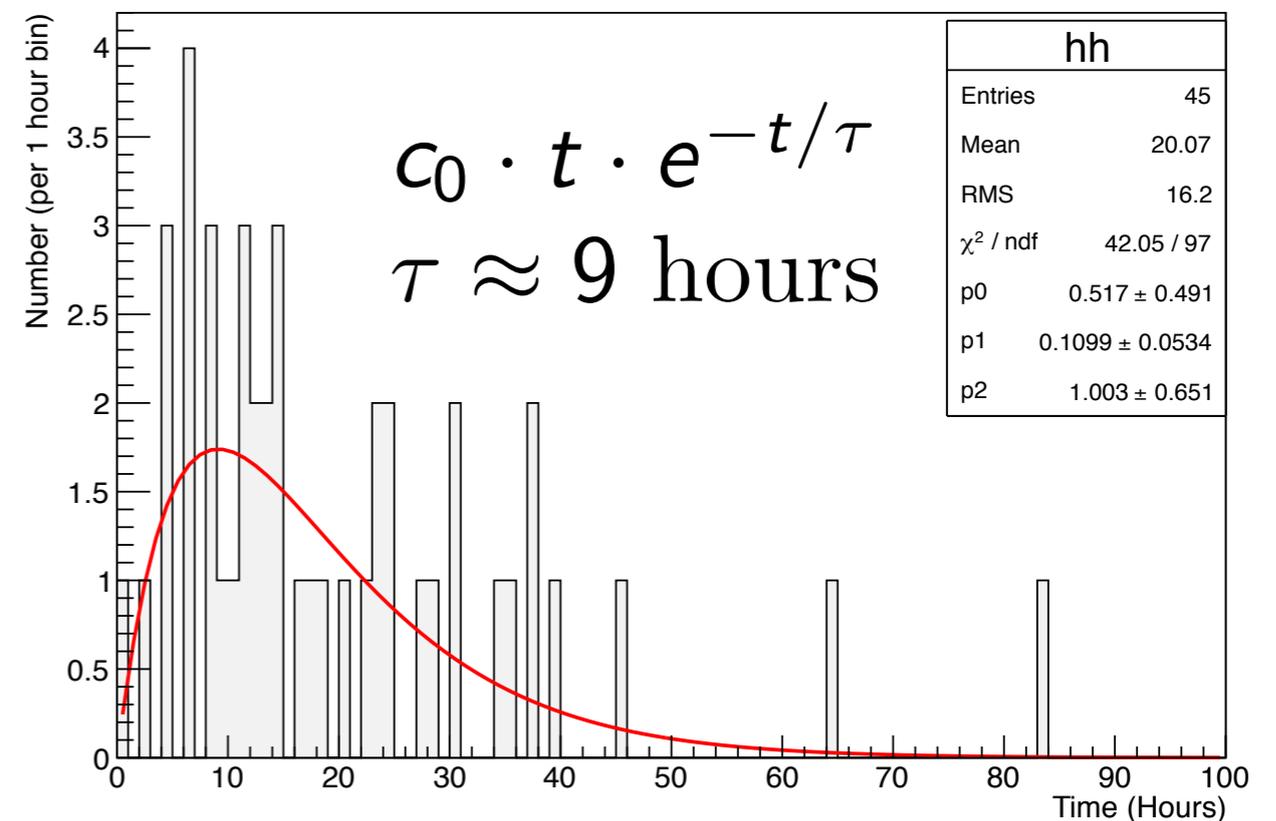
Period of Holding HV (4/25-6/2)

Are The Delayed Discharges Random?

- If this was a Poisson process, the time between occurrences should be a decaying exponential
- This instead seems to have a time constant associated with it.

- Pretty low statistics

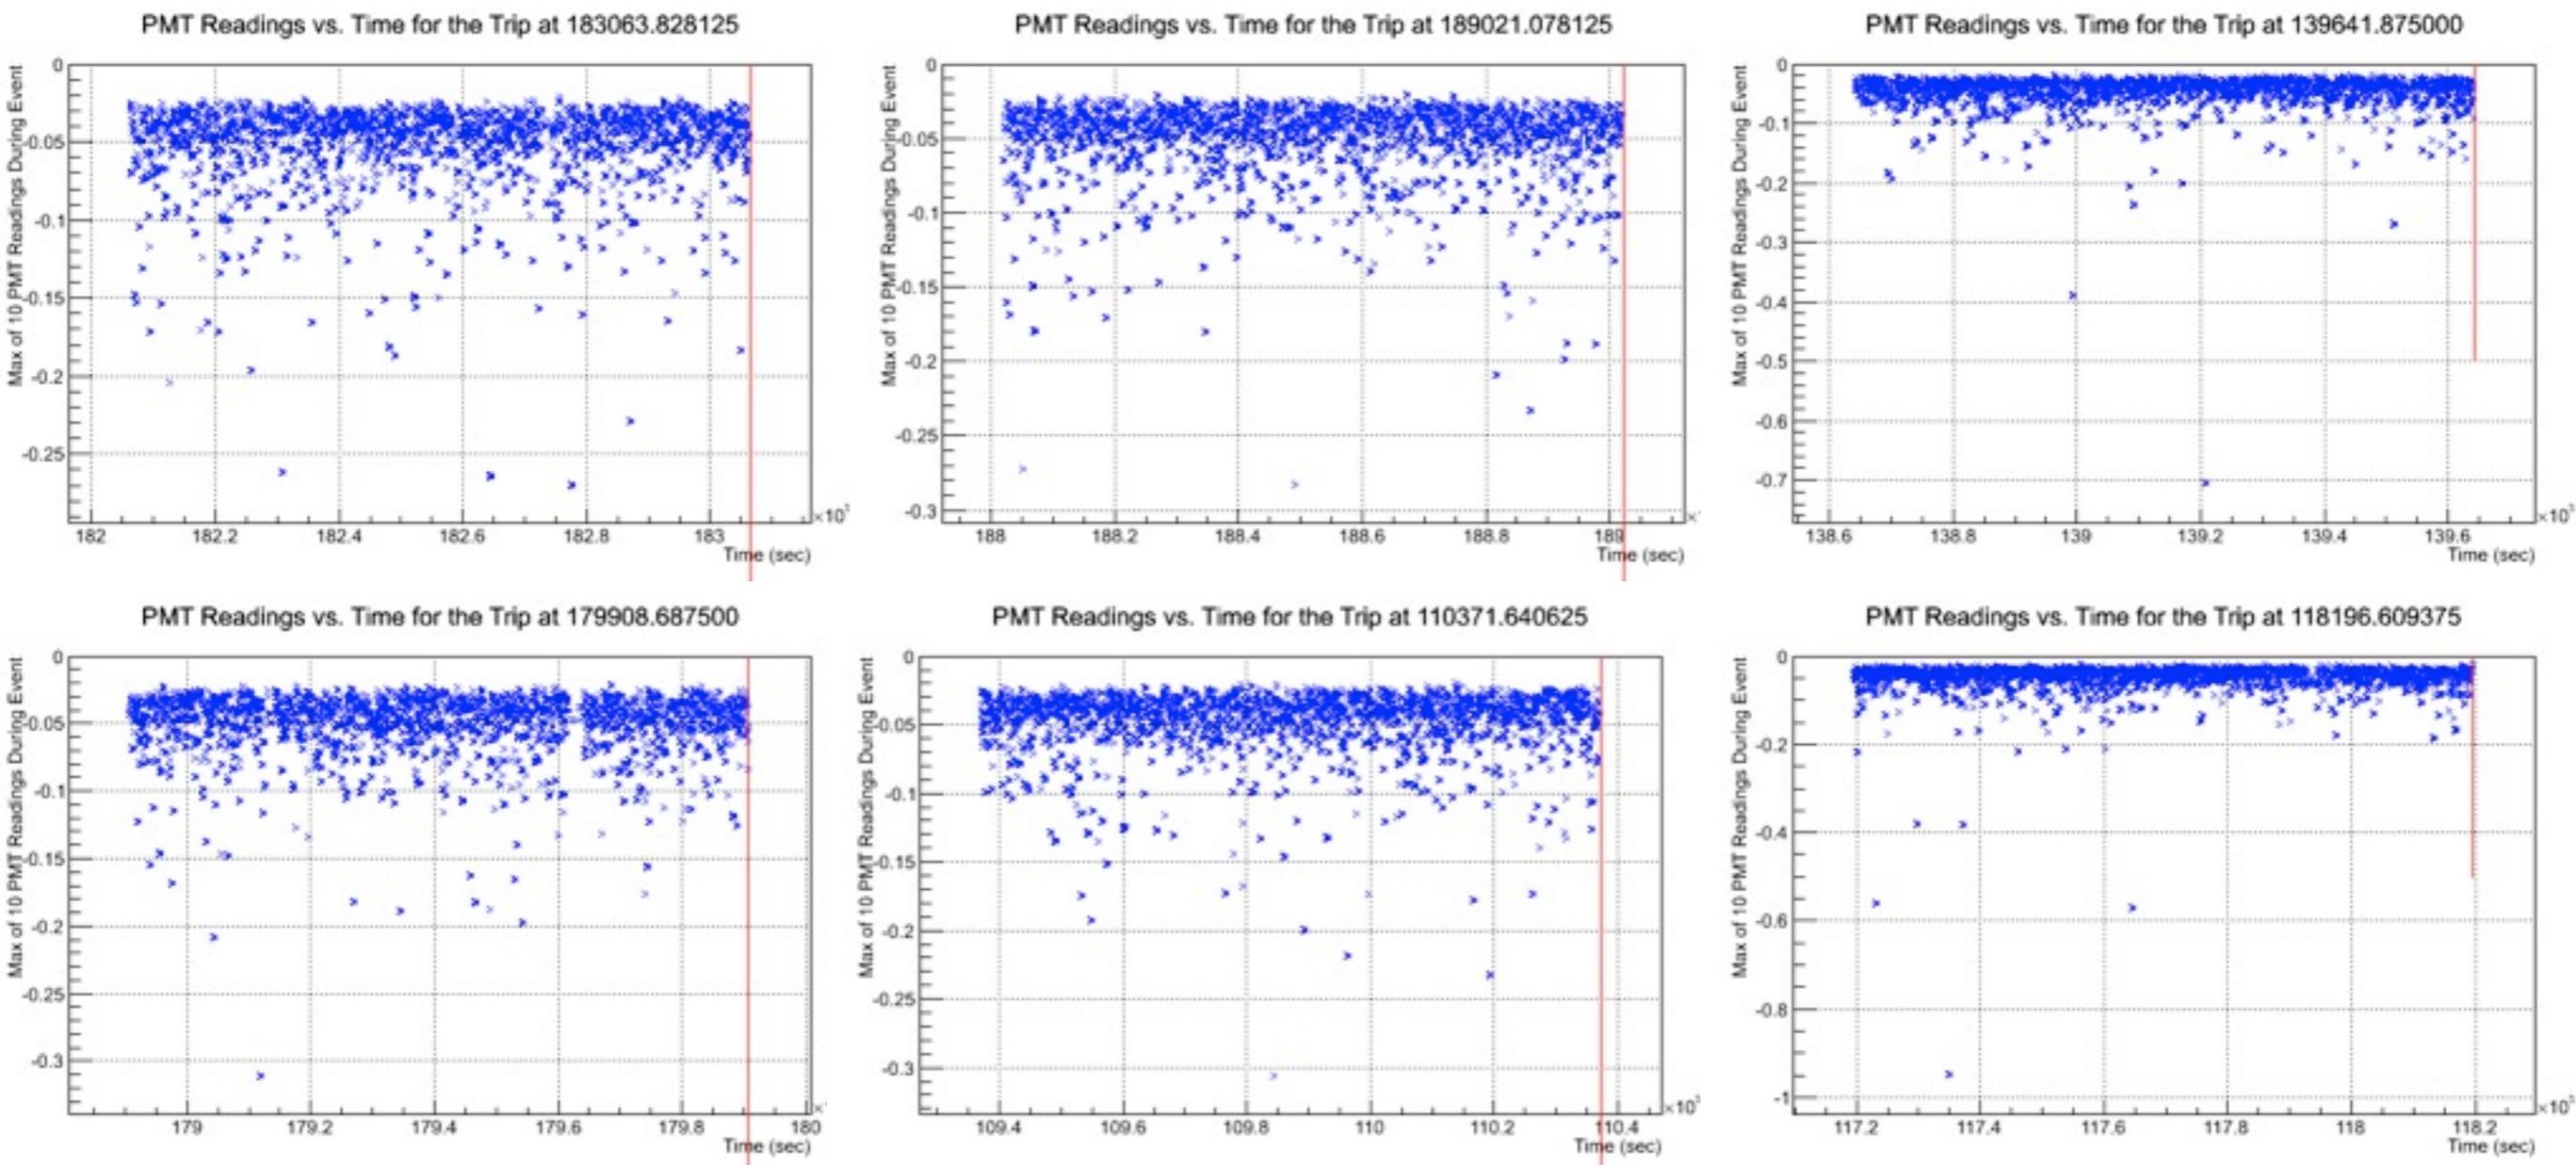
- Random subset of trips from September 3rd. No obvious correlation.

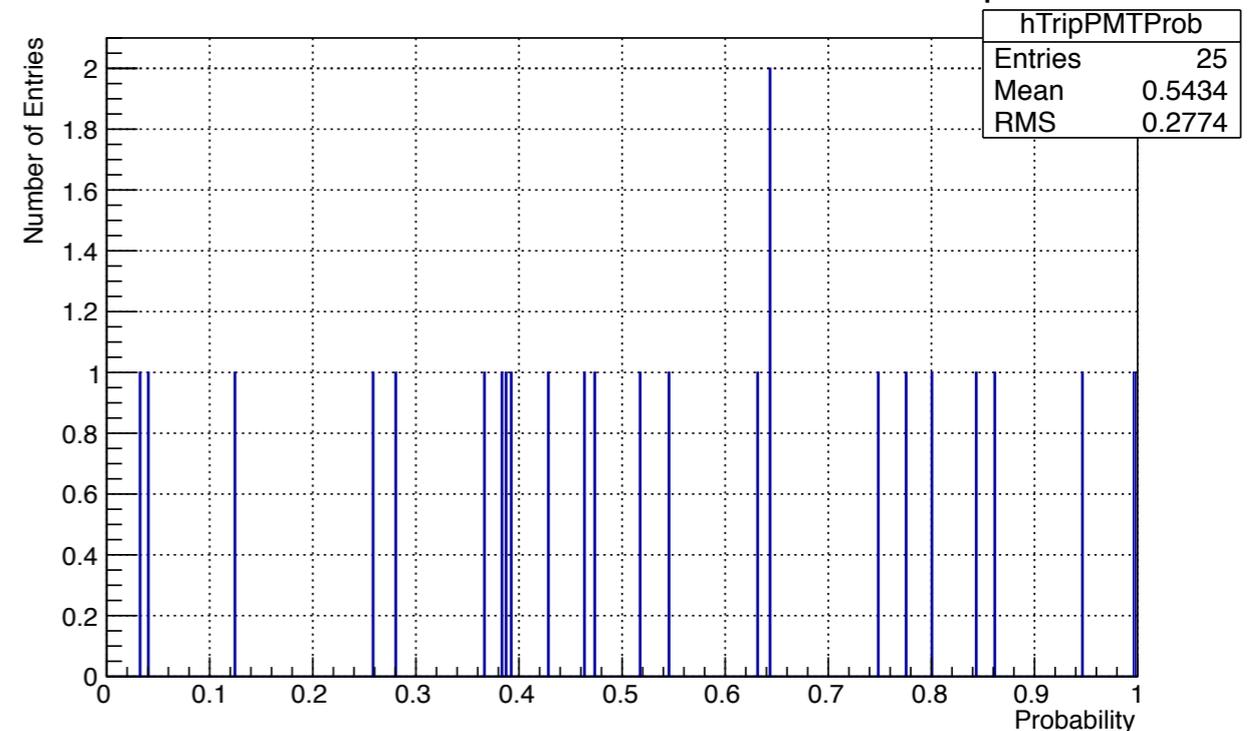
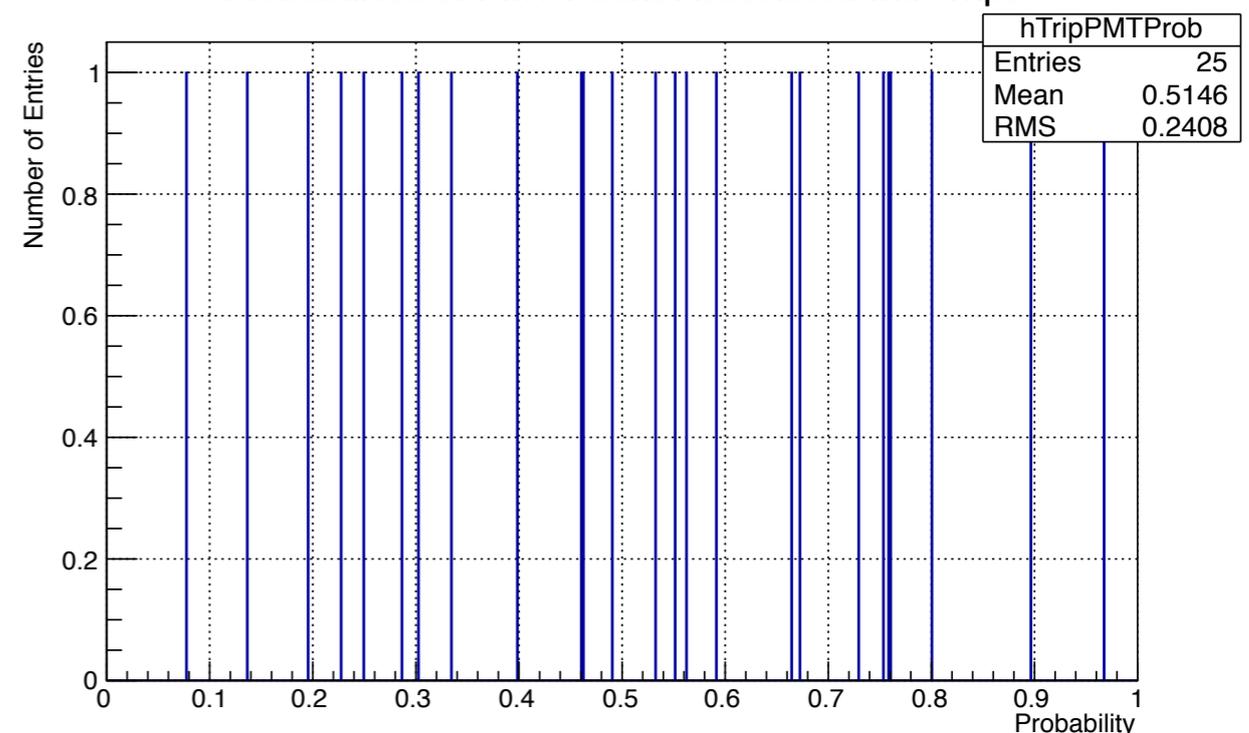
Probabilities of PMT Peaks Associated with Trips

- Probabilities of getting a given PMT pulse near a trip:
 - **Top** is considering the minimum value of the 10 recorded per triggered event
 - **Bottom** is considering 100 triggered events (99 before the trip)
- They are flat; **the discharges are not correlated with triggered events in the counter above the TPC**

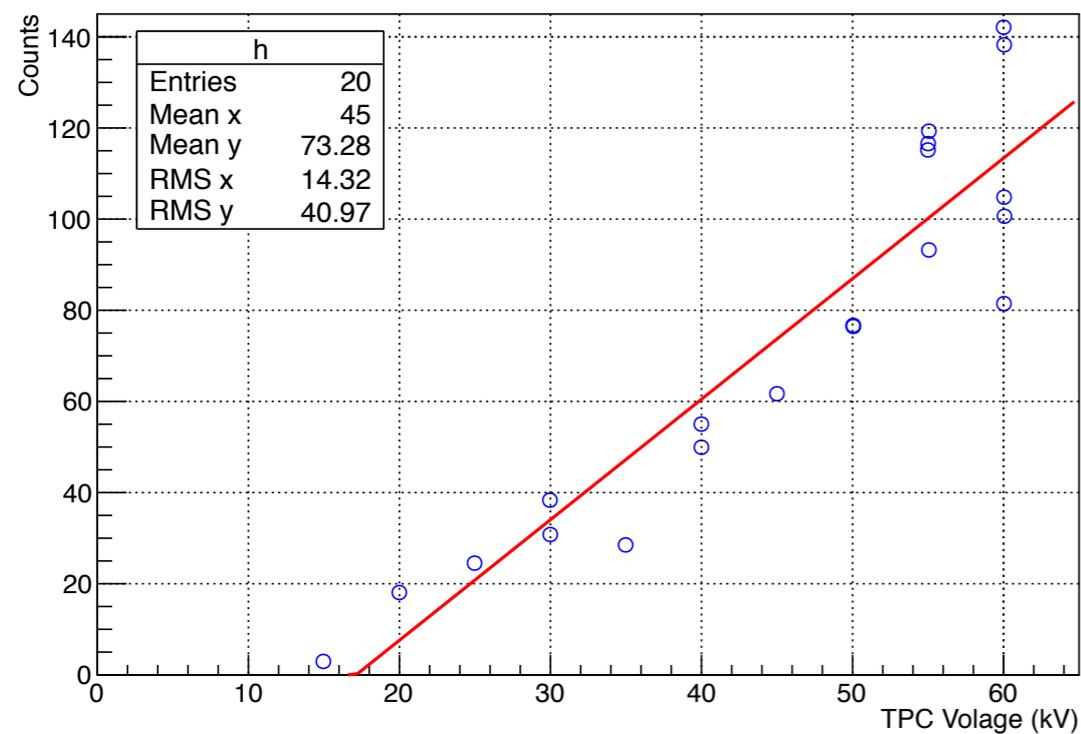
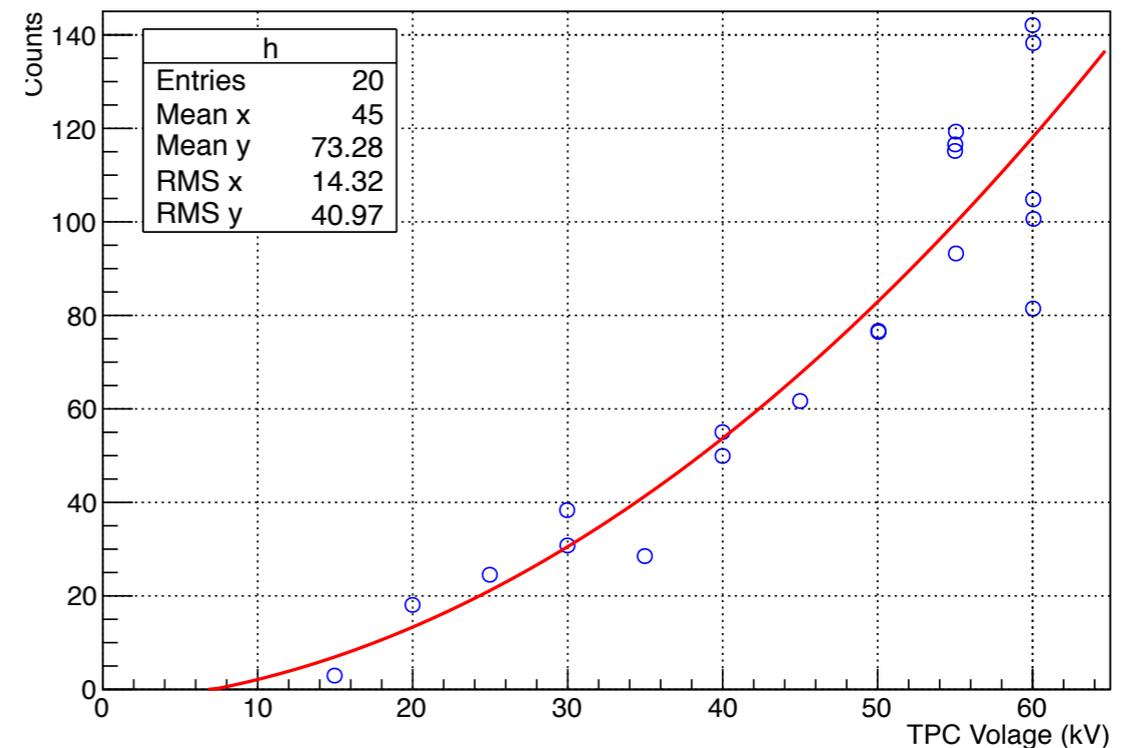
PMT Counts vs. TPC Voltage

- These are not unrelated light pulses
 - The frequency varies with TPC HV (these are counts per 60 sec):

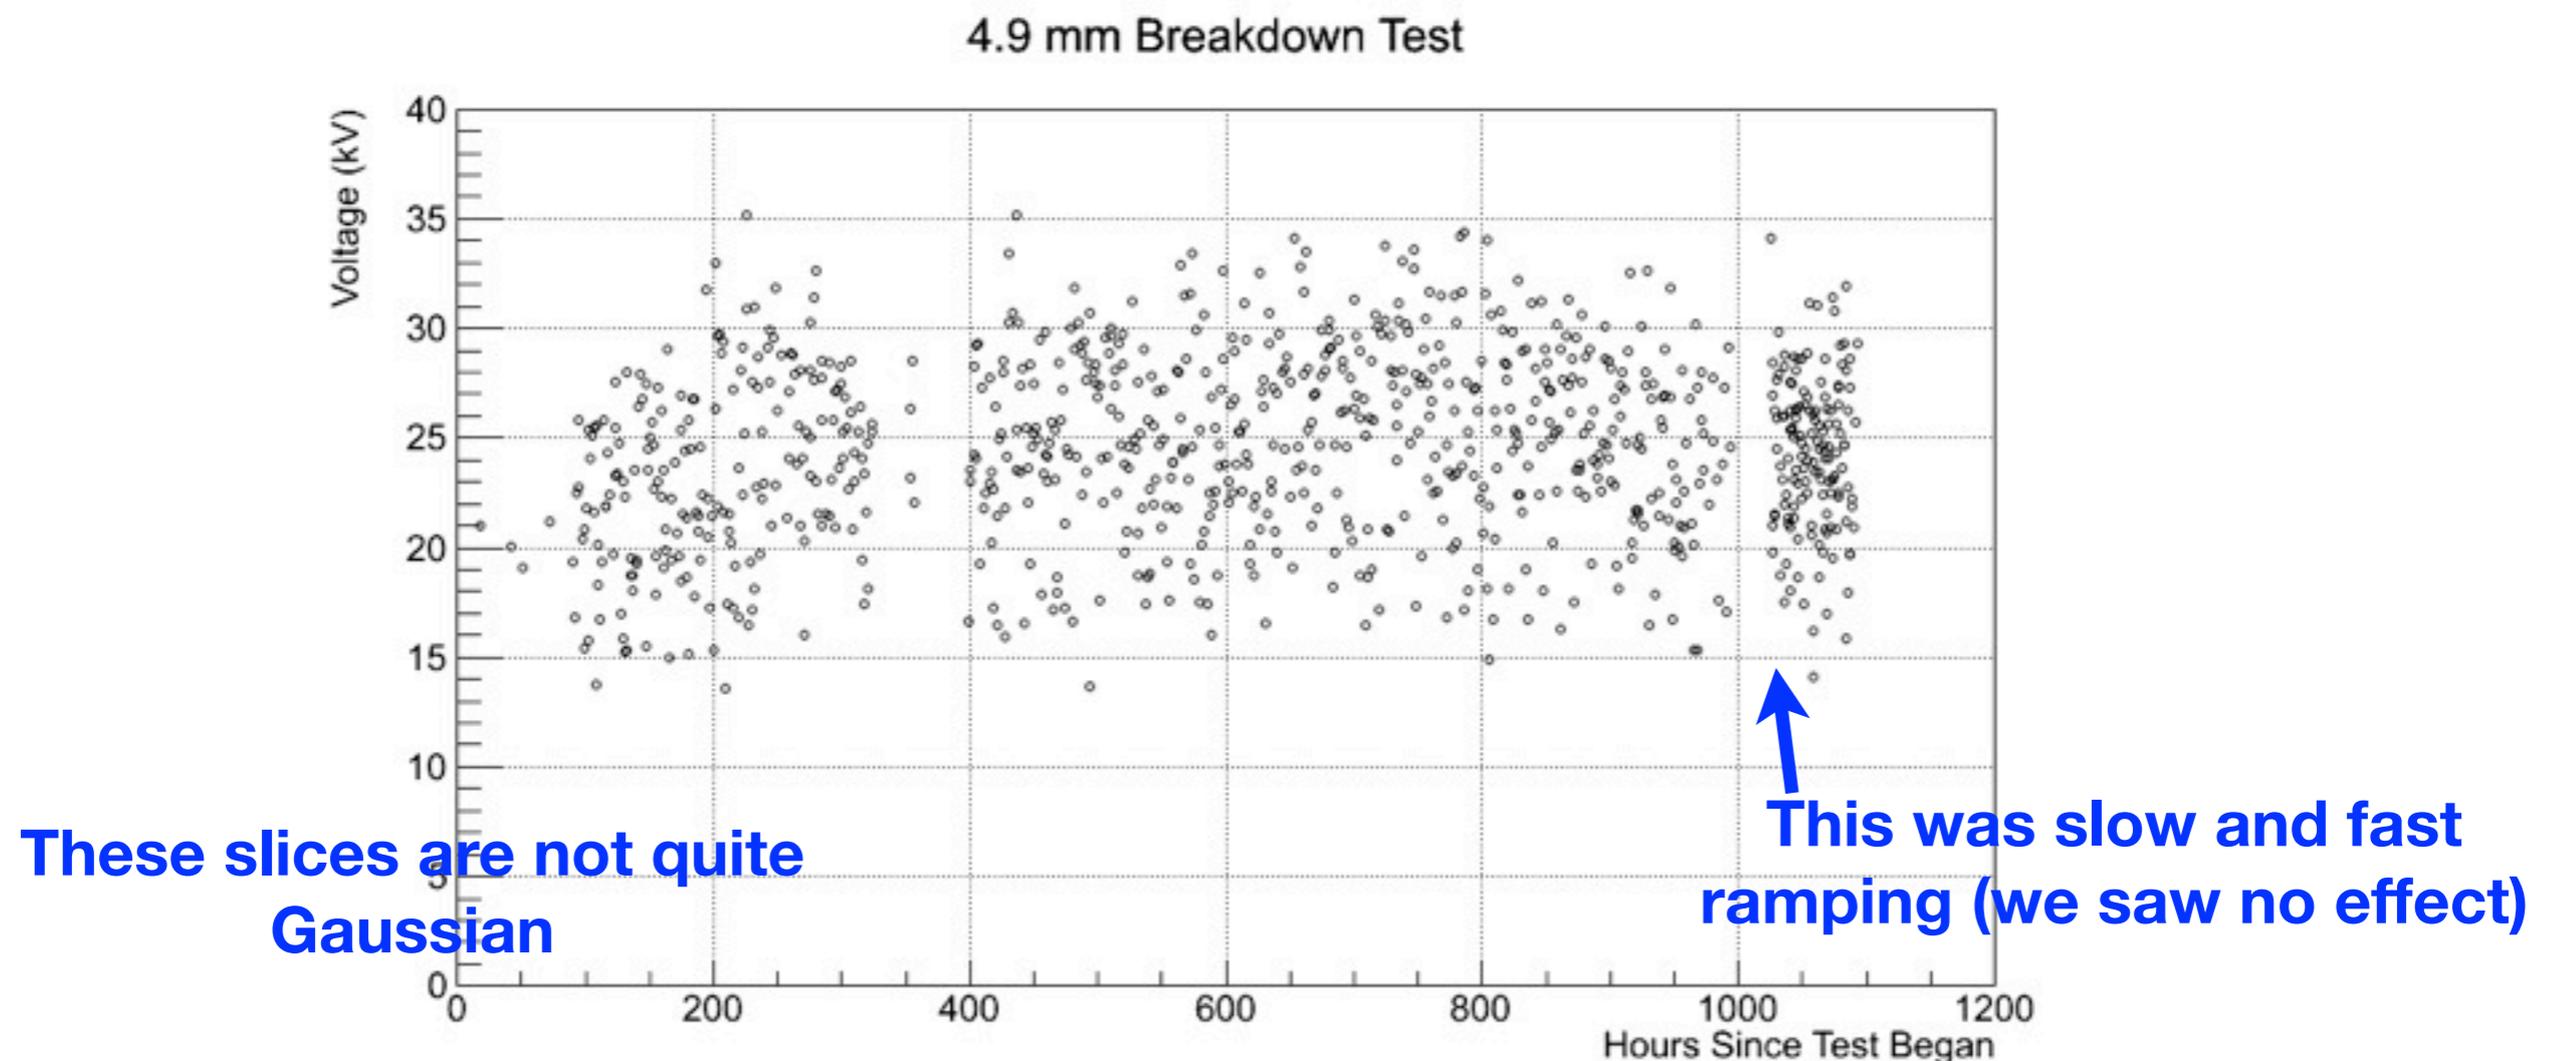
- We mostly tested every hour ramping up slowly (0.1 kV/s) to discharge (this value was recorded)
- The data seemed a bit scattered and low (DAB BDT would project something like 50 kV, but that's in dirty Ar)
