HV Items from Long Bo

MicroBooNE R&D Meeting
April 25, 2014

Slides by S. Lockwitz

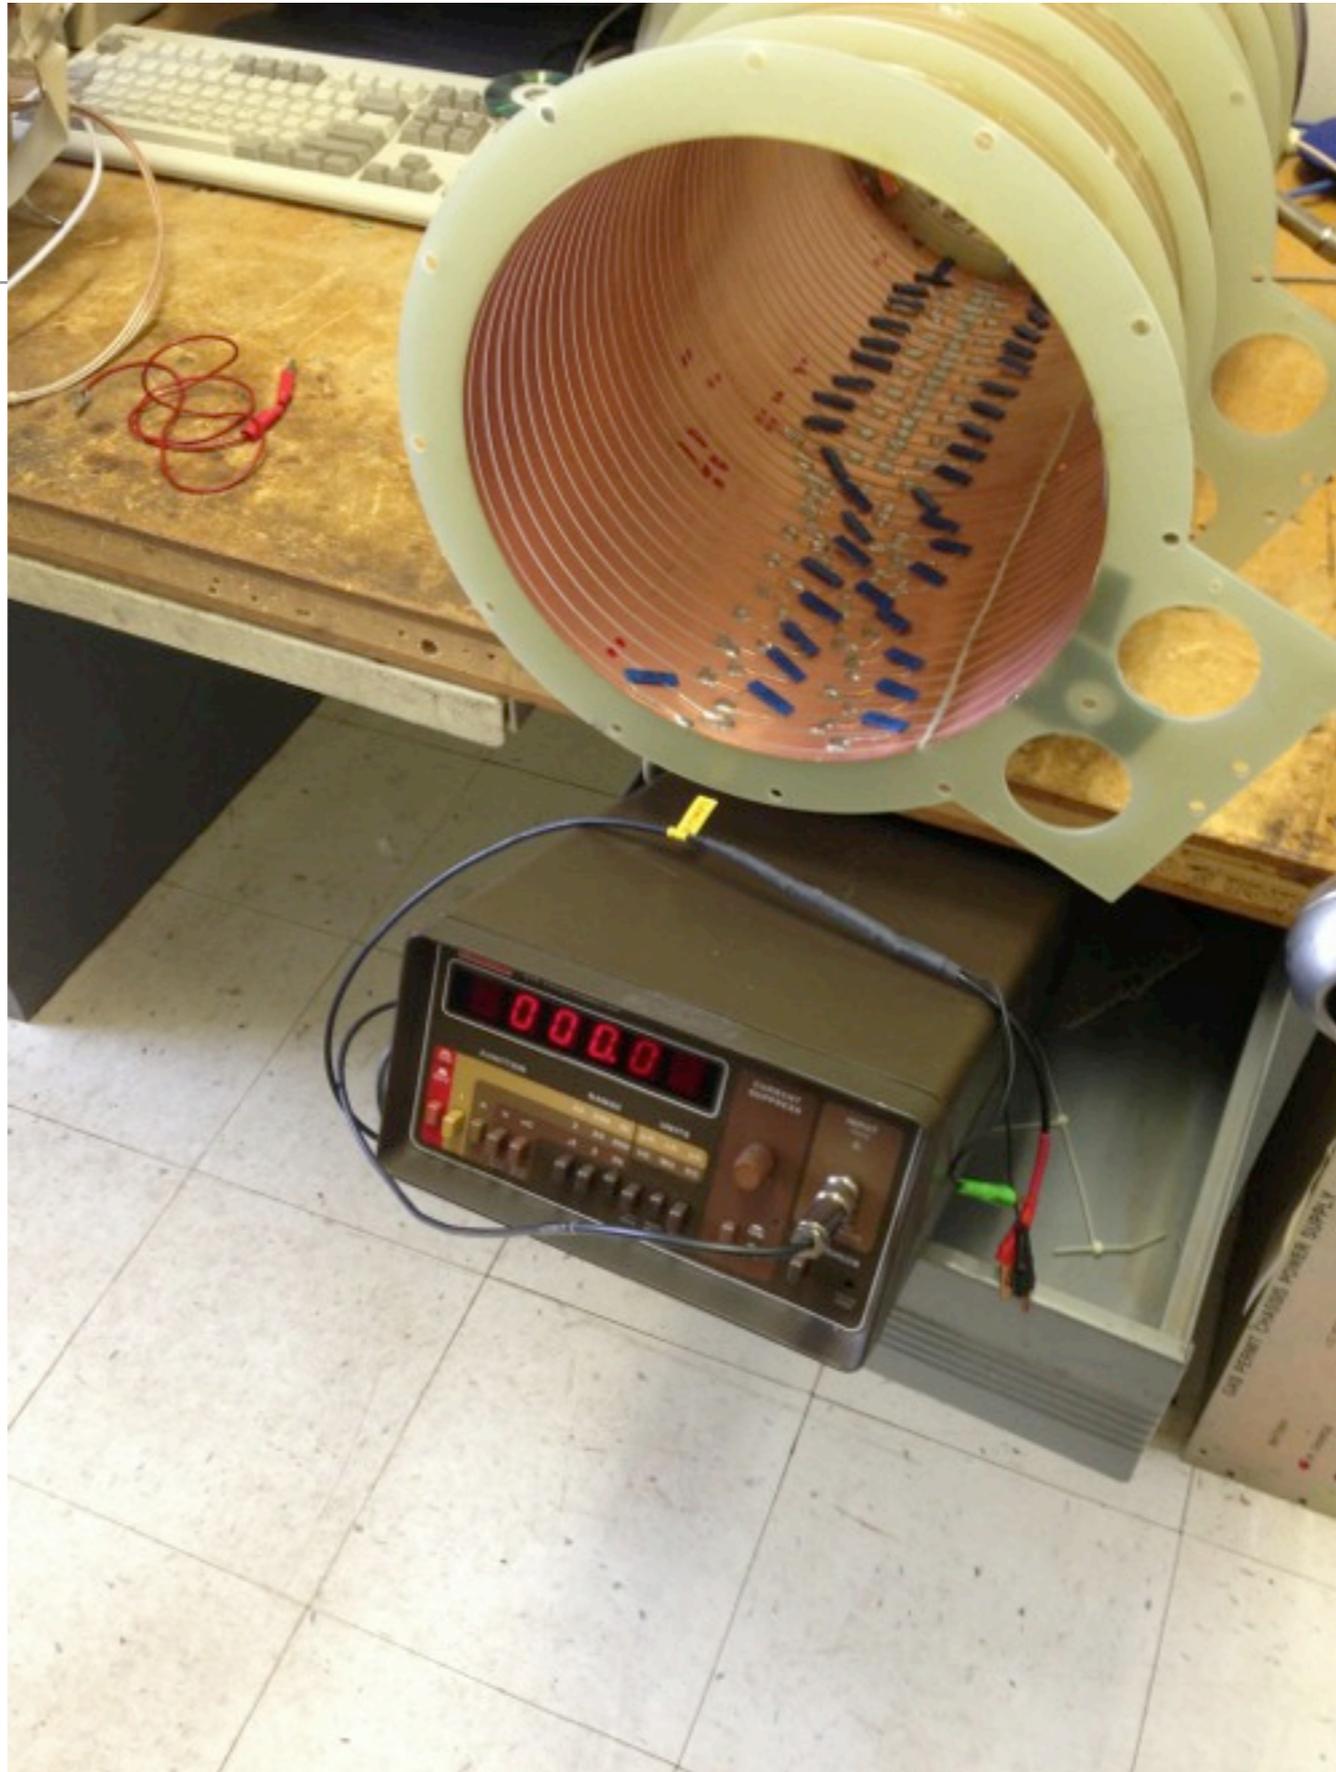
Measuring the Resistance

- This is the lowest section
- Red dots are failures
- **Six single resistor failures between rings** (4-5, 16-17, 19-20, 22-23, 23-24, 26-27, 38-39)
- **One double resistor failure** (open between rings 21-22)
- (Resistance between rings 27-28 was 80% of what it should be)

- Fail points from “Damage” slide are up here
- Those points did **not** have broken resistors on the rings
